**APPENDIX 16.3**  
**Phase IA/IB Archaeological and Architectural**  
**Investigation**

**PROJECT NUMBER 06PR03440**

**( Jardim Estates East/Sheldon Avenue/V/TARRYTOWN )**

**Phase IA/IB Archaeological and Architectural Investigation  
Jardim Estates East  
Sheldon Avenue, Village of Tarrytown, Westchester County, NY**

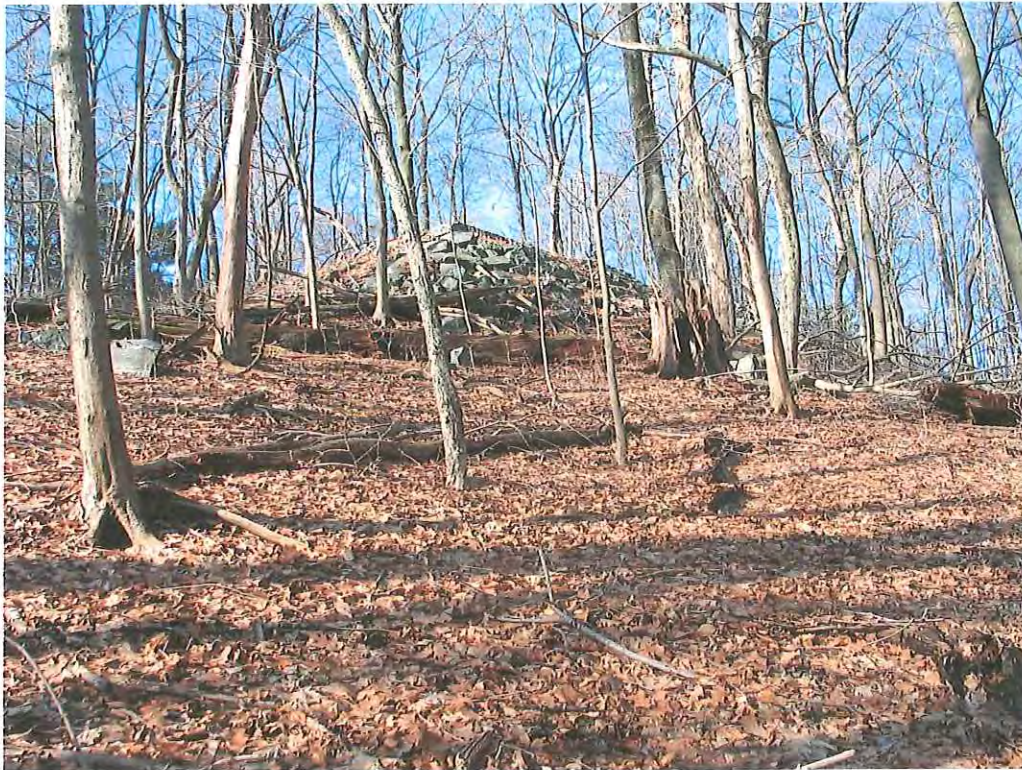
Photograph 1: Southwest corner of project site, showing steep slopes leading to large stone reservoir on hilltop. View looking southwest from roadway.

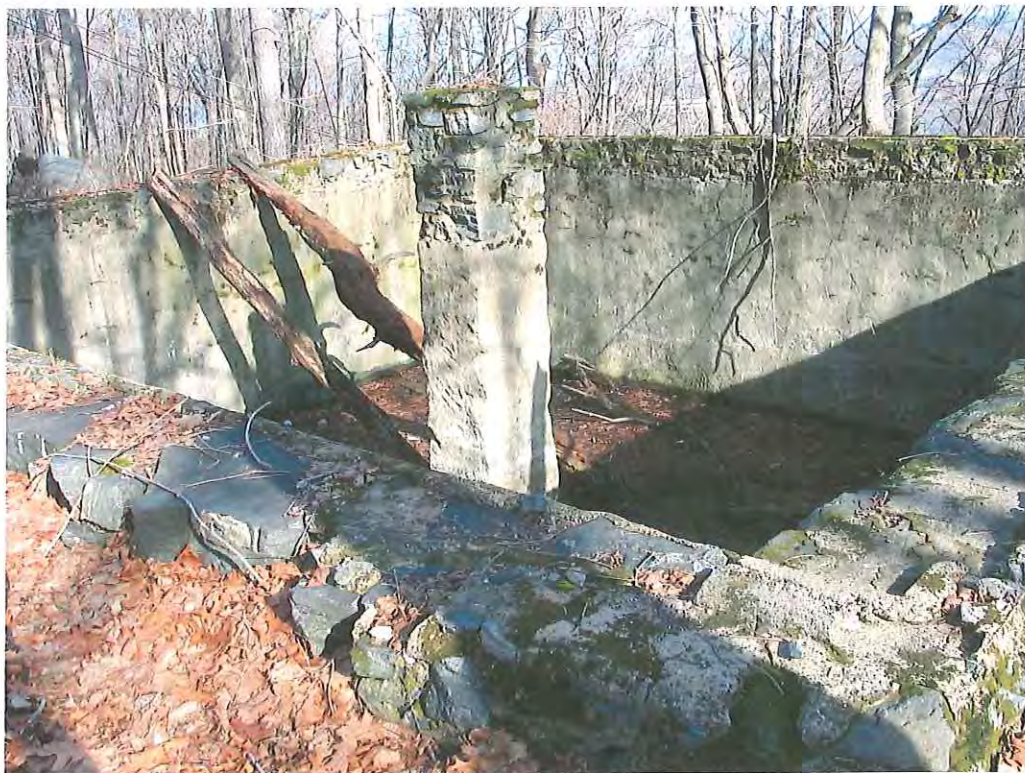
Photograph 2: Stone reservoir on top of hill at southwest corner of project site. View looking north from edge of reservoir.

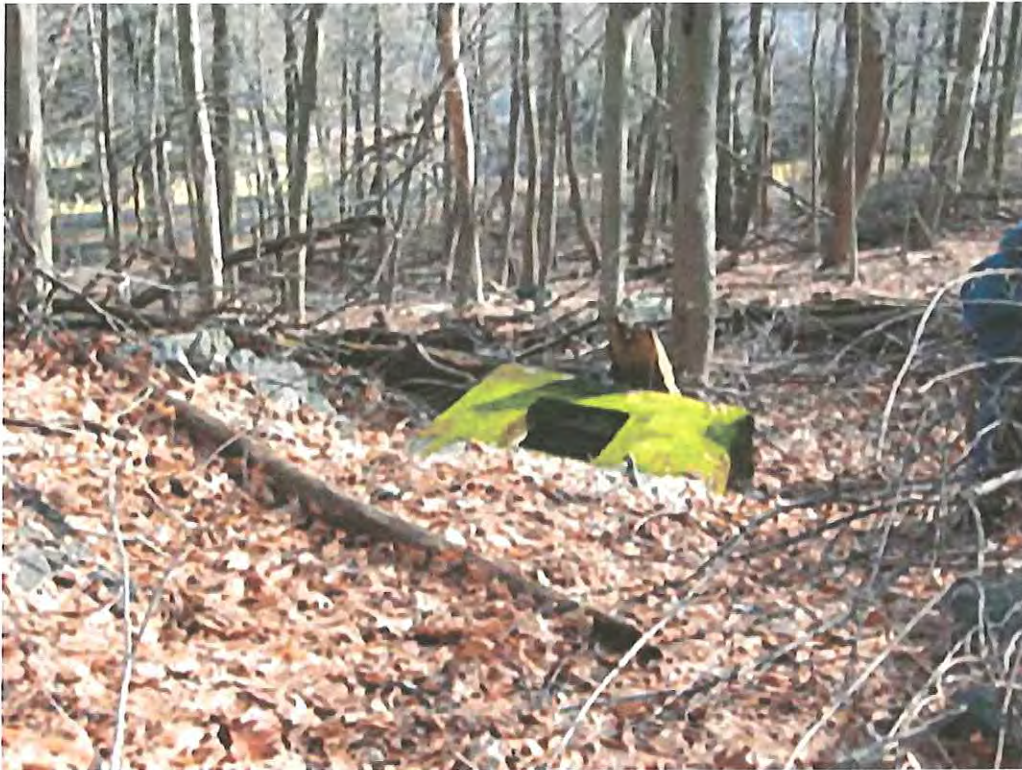
Photograph 3: Square pumping chamber on east side of stone reservoir at southwest corner of project site. View looking northeast from edge of reservoir.

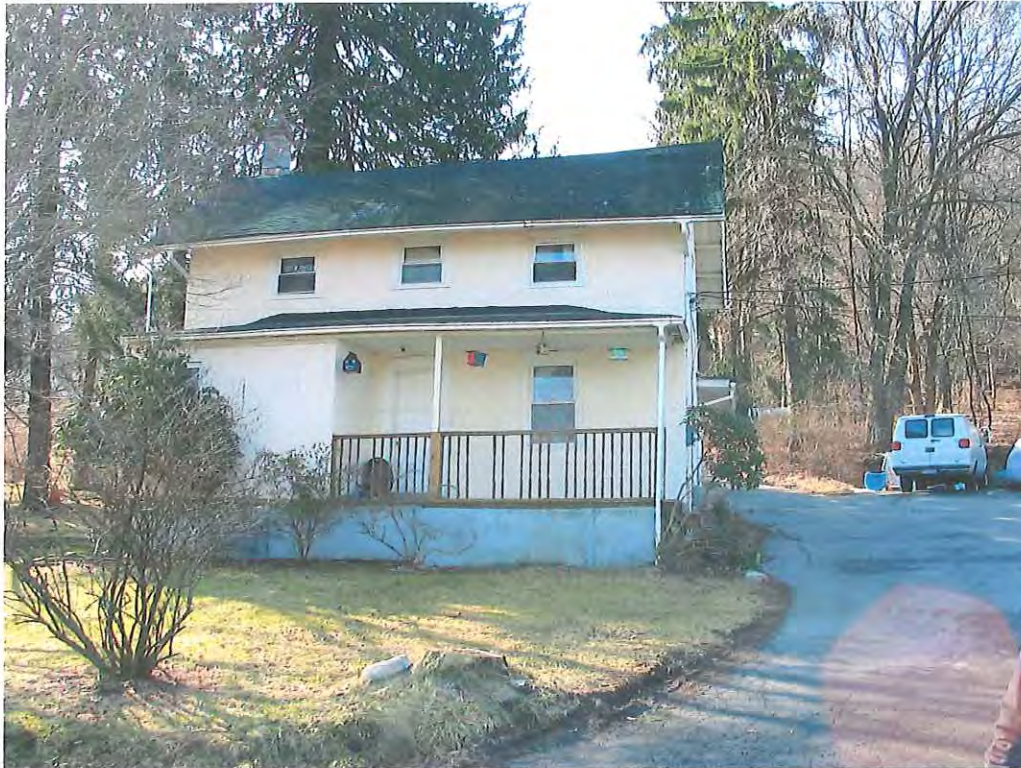
The second residence on this lot is a 2-story (with basement) vernacular frame building known as the "Gate House" with an address of 19 Gracemere Lane (Photographs 9 and 10). It faces the second entry to the project site, a road off Sheldon Avenue known as Gracemere Lane, which also has stone pillars marking the property boundary. It appears to date to the nineteenth century, and may in fact be the original ca. 1850s-1860s house built by Robert Graves shortly after he purchased the property in 1856. However, the house has been extensively renovated, including replacement of windows, and the addition of an enclosure on the east side of the front porch. Historic maps show a structure with a square footprint in this general location by the 1860s, but this specific building footprint (with a rear addition) does not appear on maps until the 1890s. For a time during the twentieth century,

Photograph 9: North (front) façade of “Gate House” just north of “Gracemere Lodge” shown in photographs 4-7. View looking south from roadway.

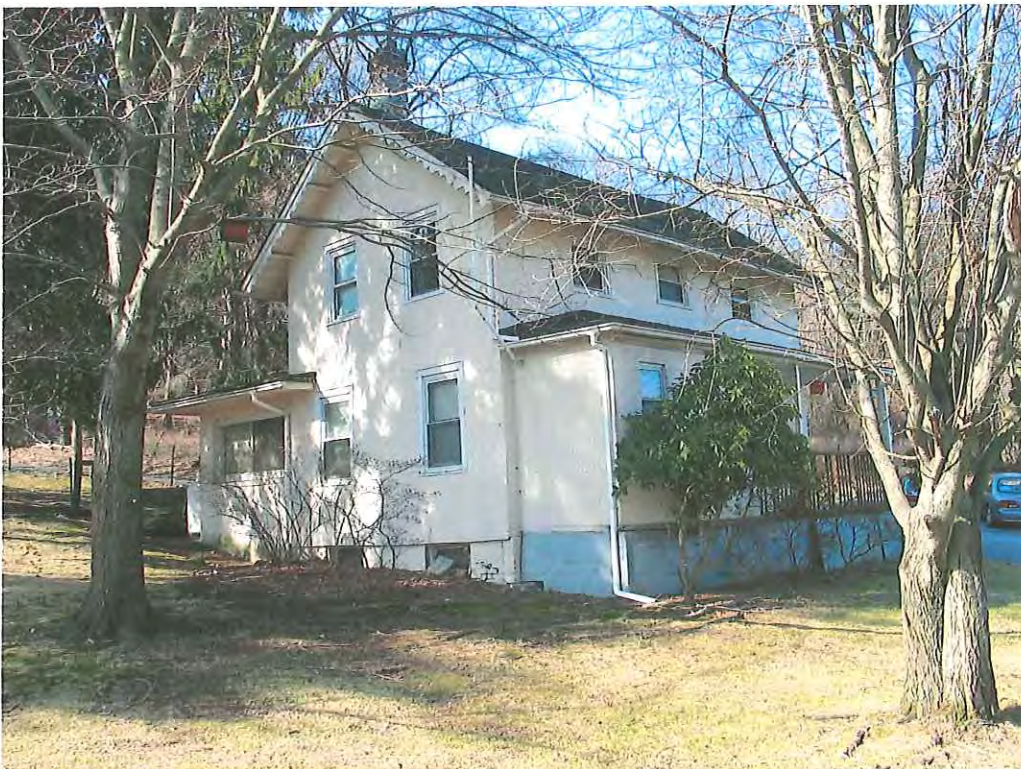
Photograph 10: North (front) and east (side) façades of “Gate House” just north of “Gracemere Lodge” shown in photographs 4-7. View looking southwest from roadway.

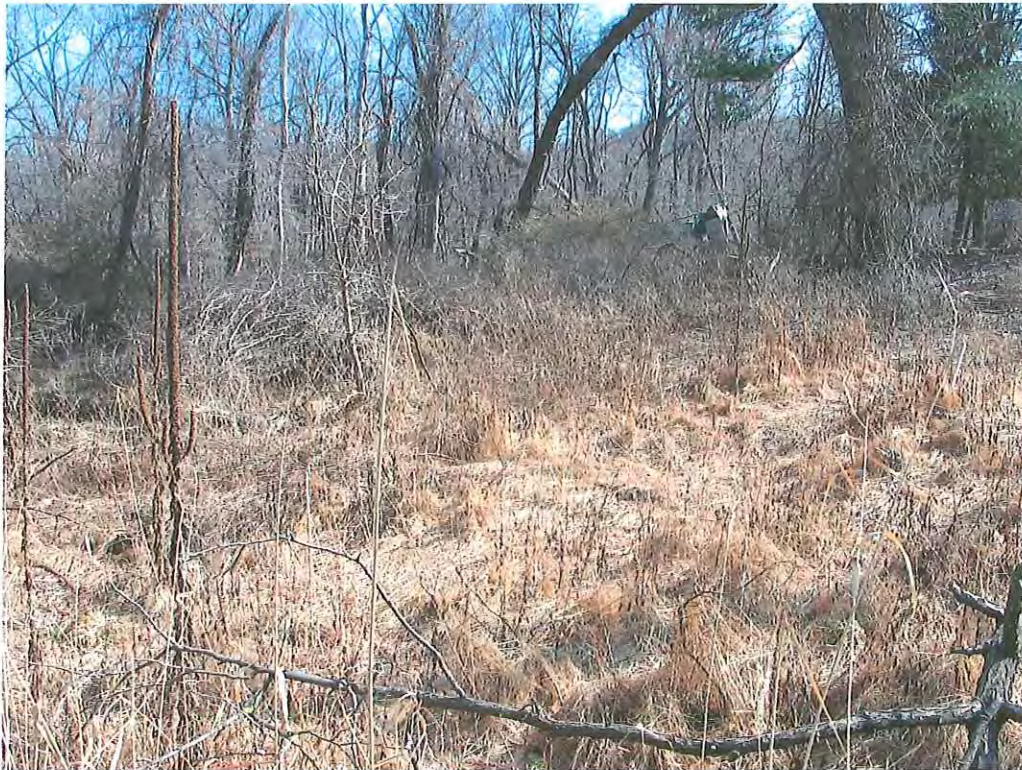
demolition process in ca. 2005 has rendered the former location of this house, as well as the remainder of this parcel, extensively disturbed (Photograph 27). No evidence of any intact portion of the former house foundation was visible or observed. Instead, large fragments of stone and bricks were noted in churned up piles. Only a portion of a former addition or outbuilding was still present. The extensive surface examination of this location found that the ground surface within the entire parcel was completely disturbed by the large-scale demolition of the structures by heavy machinery.

Photograph 27: Former location of Browning mansion, demolished in 2005. Note extensive disturbance to entire area. View looking northeast.

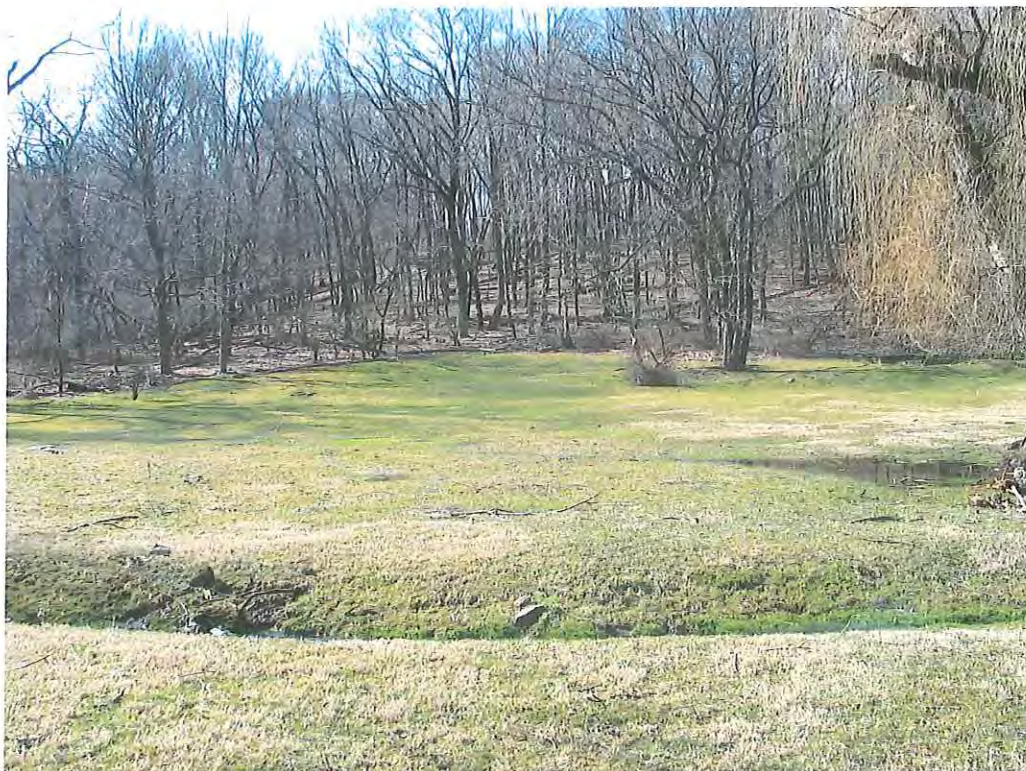
South of the Gracemere Hall parcel is a thin strip of land bounded on the north by a paved roadway and on the south by the Tarrytown village line (Photograph 28). The stream that feeds the lake originally ran within this parcel; today it has been moved and altered to such a degree that it is only visible in spots, including in a channelized trough along the southern side of the roadway, and wet areas south of the trough (Photographs 28-31). The western side of this parcel is vacant land once used for gardening. It contains stone foundation remains of a greenhouse, as well as furrows in the ground that probably represent old planting beds (Photographs 32 and 33).

Photograph 28: Land southwest of Gracemere Lane containing a channelized trough containing the drainage that feeds "Gracemere Lake" bordering the roadway. Note wetland on right. View looking southwest from Gracemere Lane.

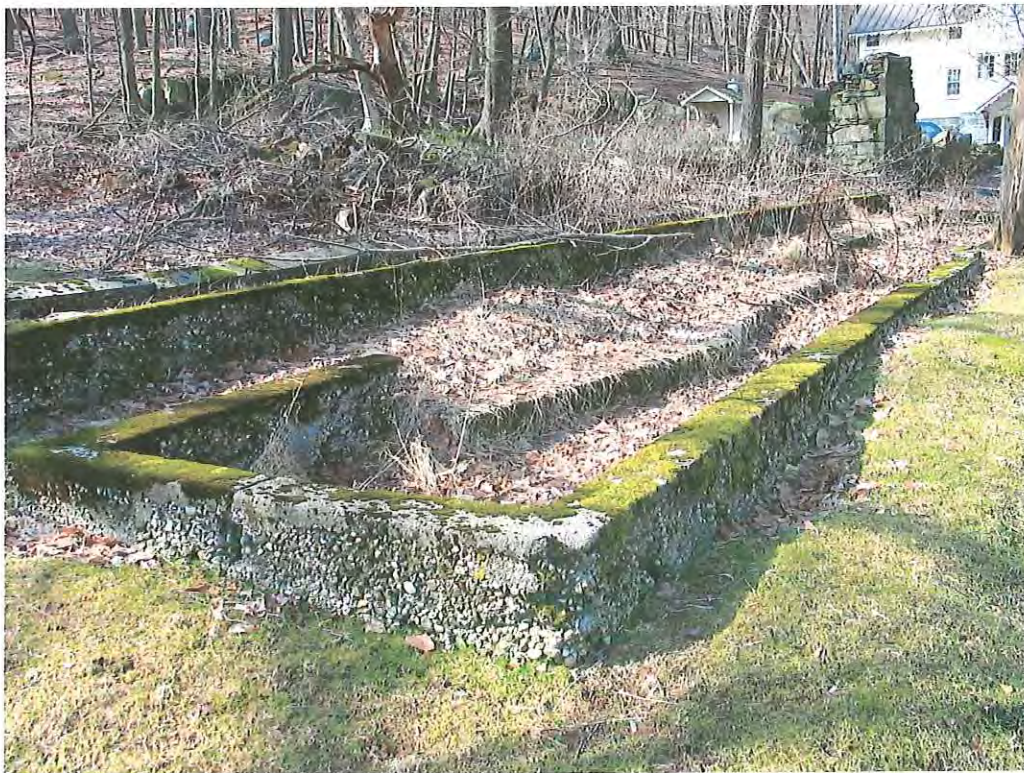
Photograph 32: Stone foundation remains of a greenhouse, located near southern edge of project site. View looking west.

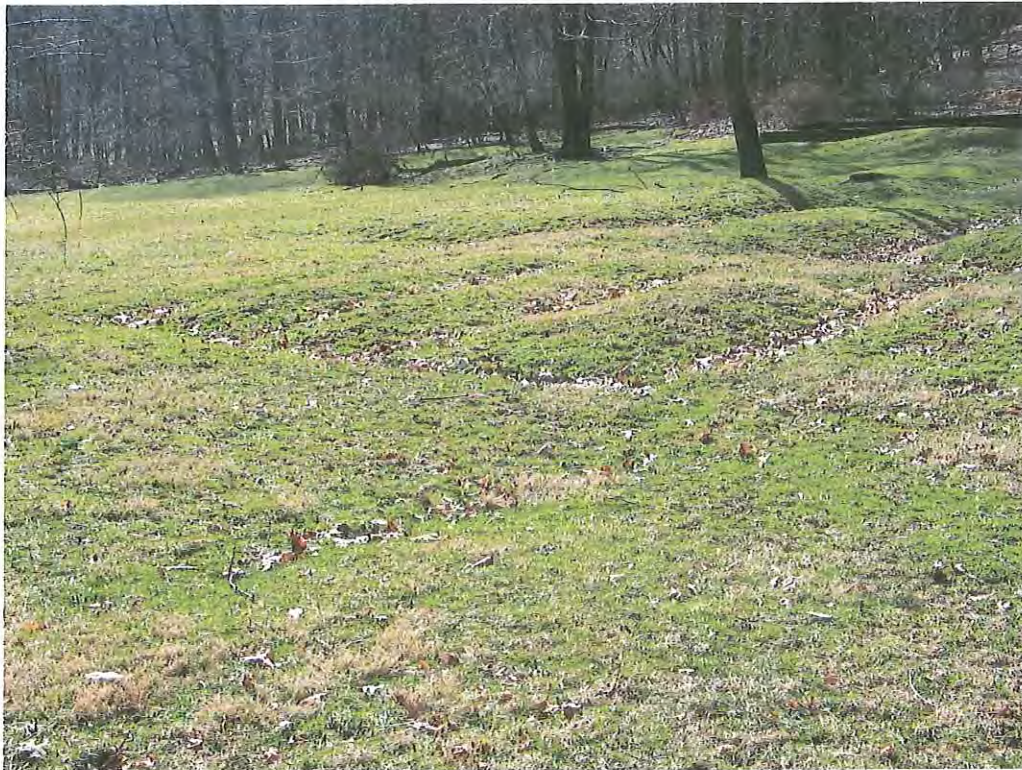
Photograph 33: Furrows in the ground that probably represent old planting beds, located east of the greenhouse remains shown in the previous photograph. View looking southwest.

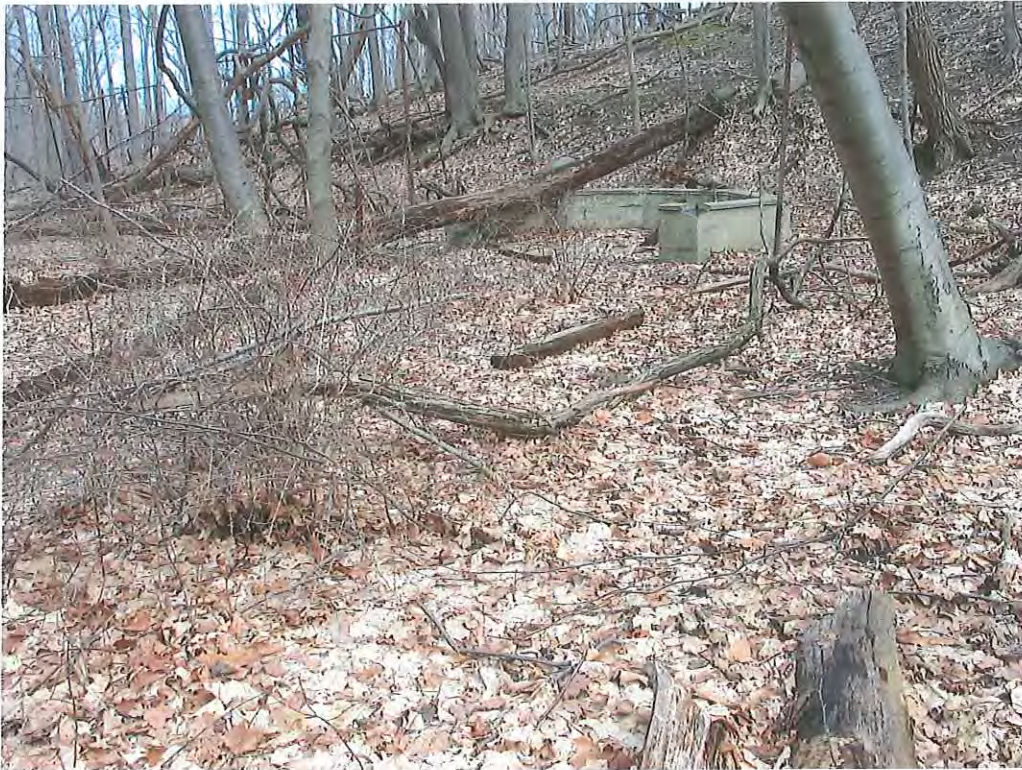
There are a number of additional concrete features along the east side of the drainage, some of which presumably were related to channeling the stream. These include a possible pump house (with pipes still visible) near Turtle Pond, a stone channel (Photograph 44) and a series of spigots along the stream. A small concrete foundation remnant (surrounded by a high chain link fence) is located on the east side of the stream as well (Photograph 45). This structure does not appear on any historic maps, and its function is unclear.

Photograph 45: Small concrete foundation remnant (surrounded by a high chain link fence) on the east side of the stream. View looking east.

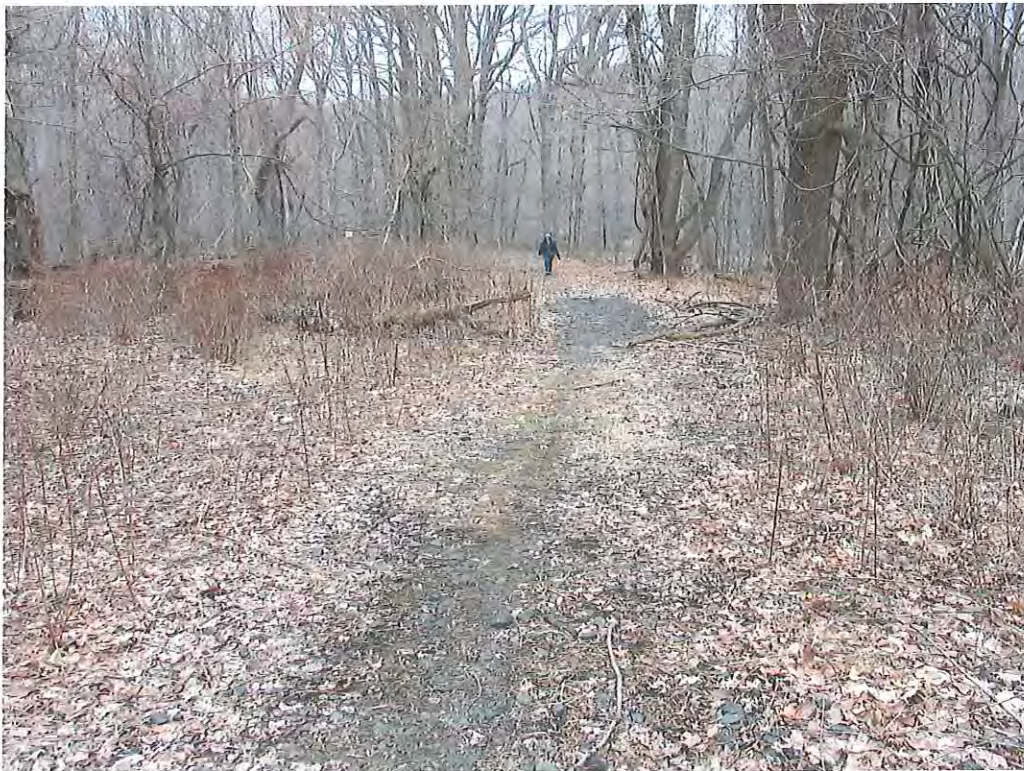
The third entry to the project site is along a right-of-way running south from Sheldon Avenue on the east side of the project site. At the end of this roadway, there is a remnant of a former private driveway that led to a twentieth-century residence (Photograph 46). The former house appears on the 1950 Sanborn map, and was attributed to "Hyman." Only the concrete foundation is visible today, and a large tree in the center attests to decades of abandonment (Photograph 47).

Photograph 46: Remnant of a former private driveway that led to a twentieth-century residence at the southeastern end of the project site. View looking south.

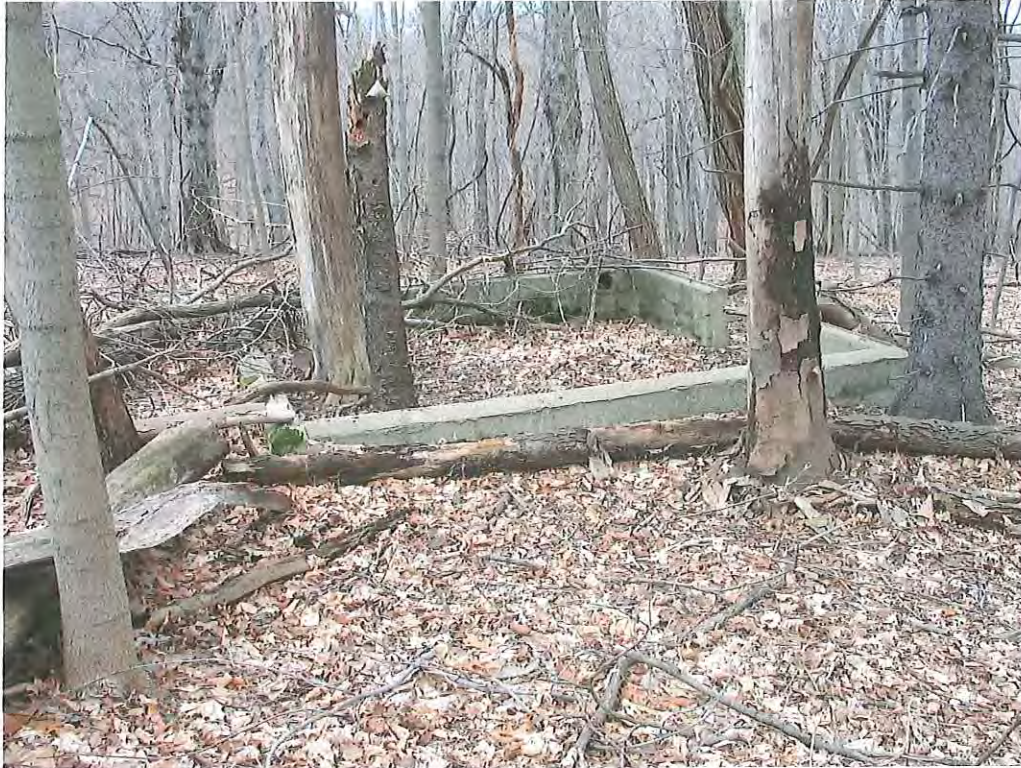
Photograph 47: Concrete foundation of former twentieth-century house at southeastern end of project site. View looking west.

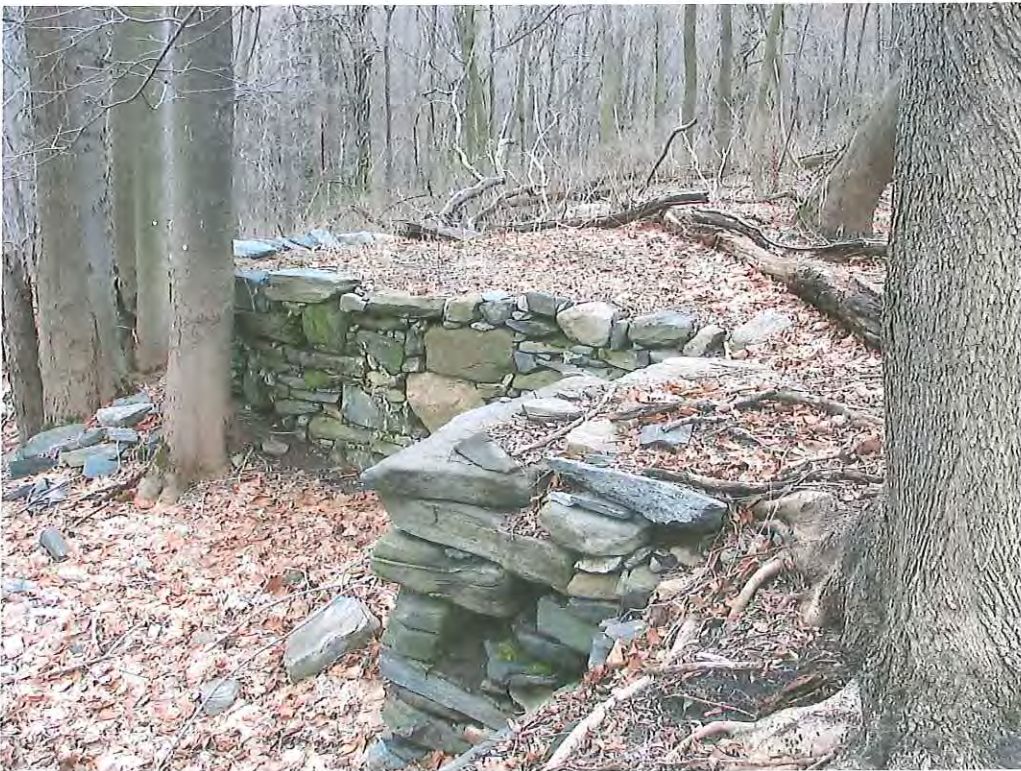
Near the Sheldon Avenue end of the parcel are remains of the former Schneider residence (Photograph 48). The foundation, of fieldstone, is located along the side of a ridge. Remains of outbuildings were also visible (Photograph 49). The 1900 Federal Census indicates that John Schneider lived there with his wife Caroline and three sons. The family moved to Ridgefield, Connecticut by 1910. The buildings were probably demolished sometime during the 1930s; the last historic map that shows them is the 1931 Hopkins map. Artifacts littering the ground surface near these former buildings at the time of the field survey dated from the late nineteenth and early twentieth century.

Photograph 48: Remains of the former Schneider residence, located on knoll near Sheldon Avenue. View looking south.

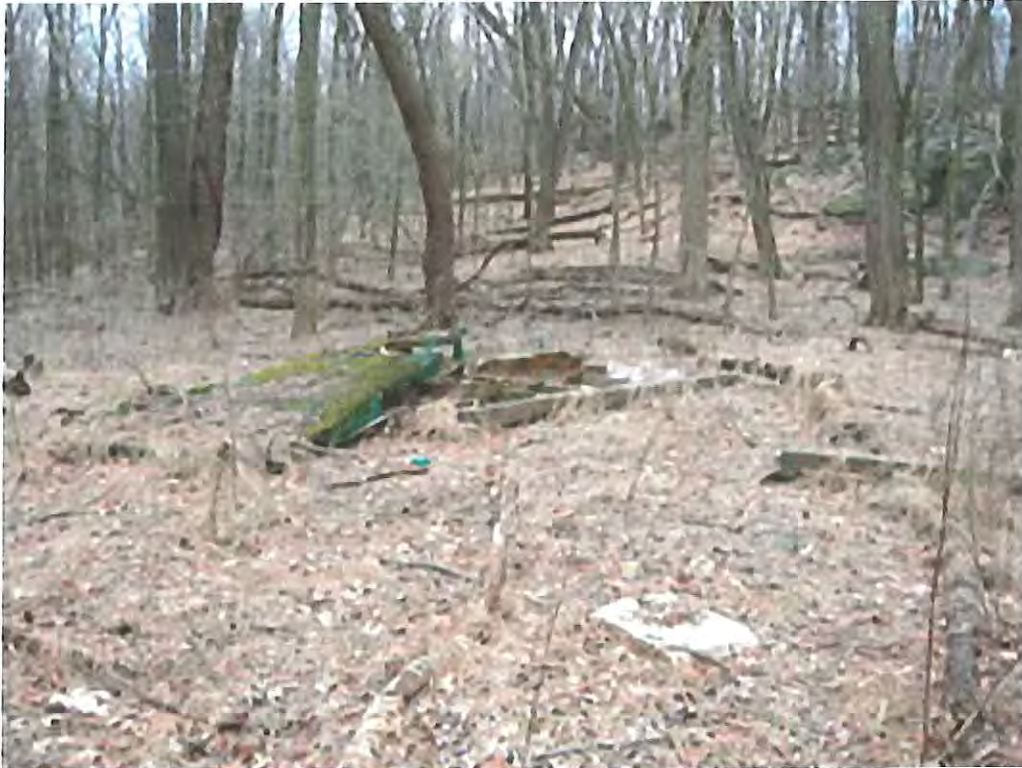
Photograph 49: Outbuilding of former Schneider residence, located south of the main house. View looking south.

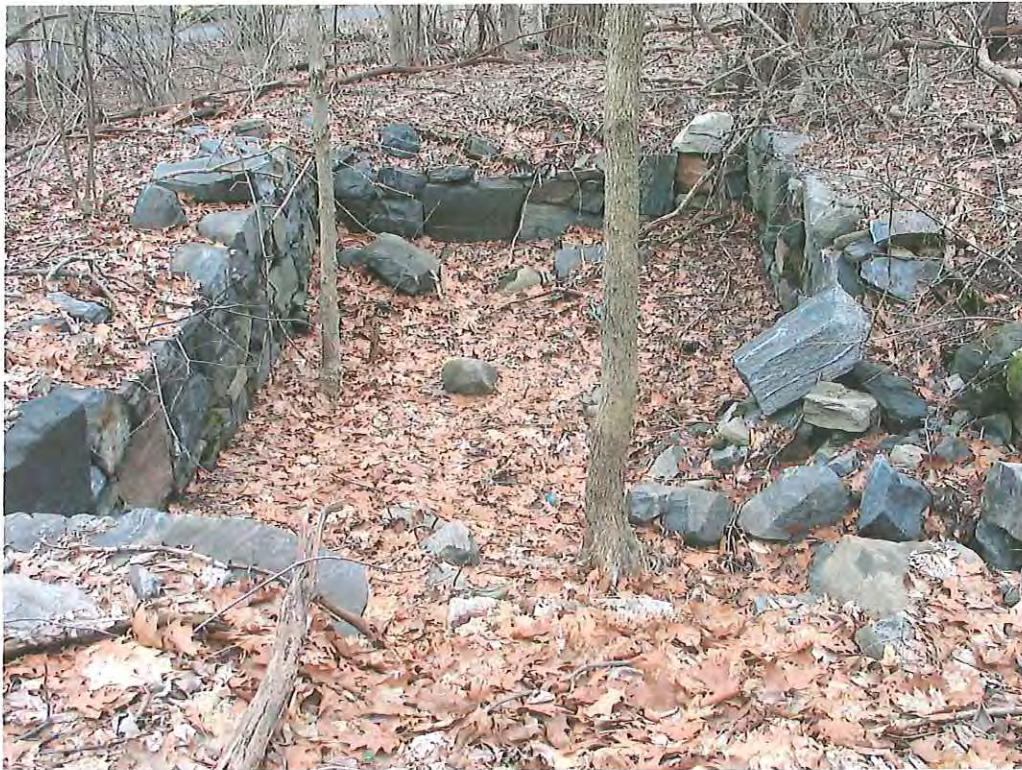
Near the northeastern edge of the project site, one unmortared fieldstone foundation from a former house is still visible (Photograph 51). It is rectangular-shaped, and measures approximately 20 feet by 12 feet. Although the field inspection did not reveal additional house foundations along the south side of Sheldon Avenue, the fact that these buildings were shown on historic maps suggests that remains of the structures (or their use) could still be present here. A stone wall marks the boundary of this parcel with the adjoining lot to the south (which is not part of the project site). Several large rock outcrops are also visible along this area.

Photograph 51: Unmortared fieldstone foundation from a former house located south of Sheldon Avenue and just west of driveway marking eastern edge of project site. View looking west.

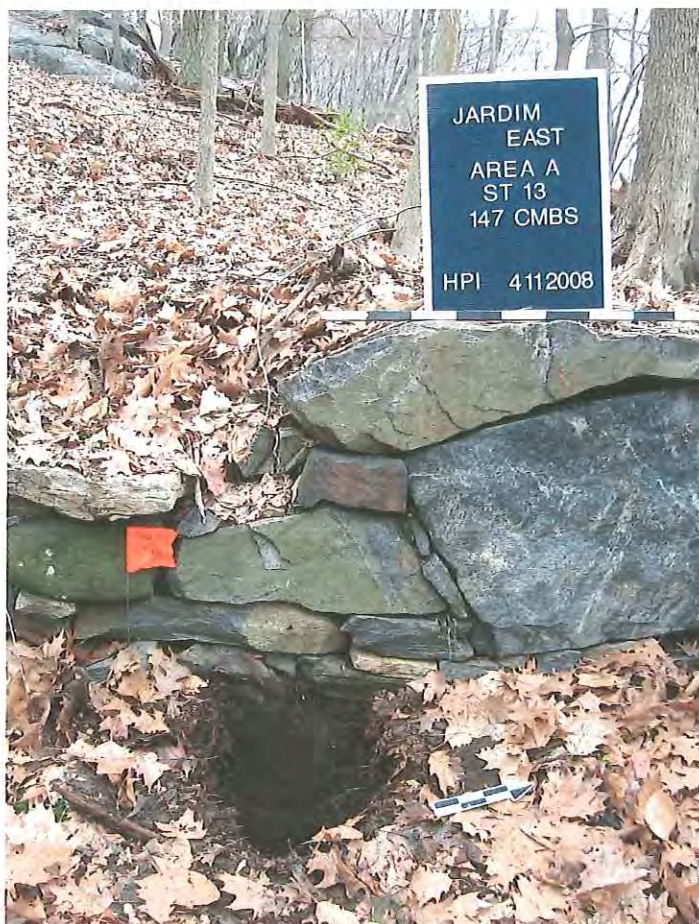
Photograph 56: ST 13 excavated within historic foundation (Feature A) in Test Area A.

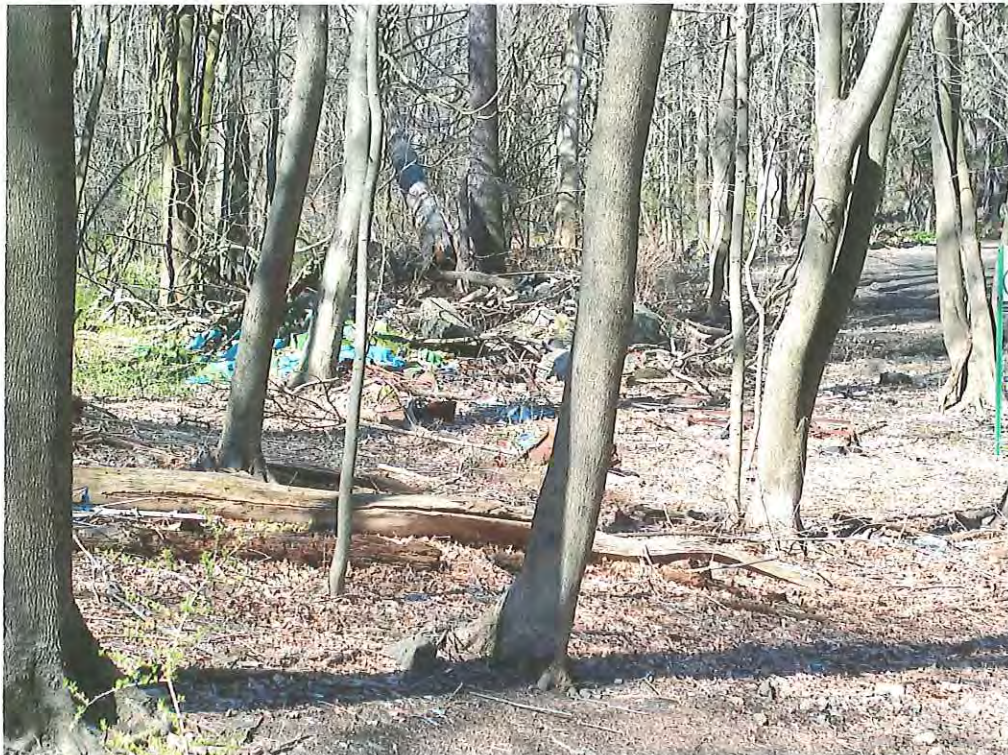
Photograph 57: Modern dumping in Test Area B.
