4

Cultural Resources

4.1 Introduction

JARDIM ESTATES EAST
Tarrytown, New York

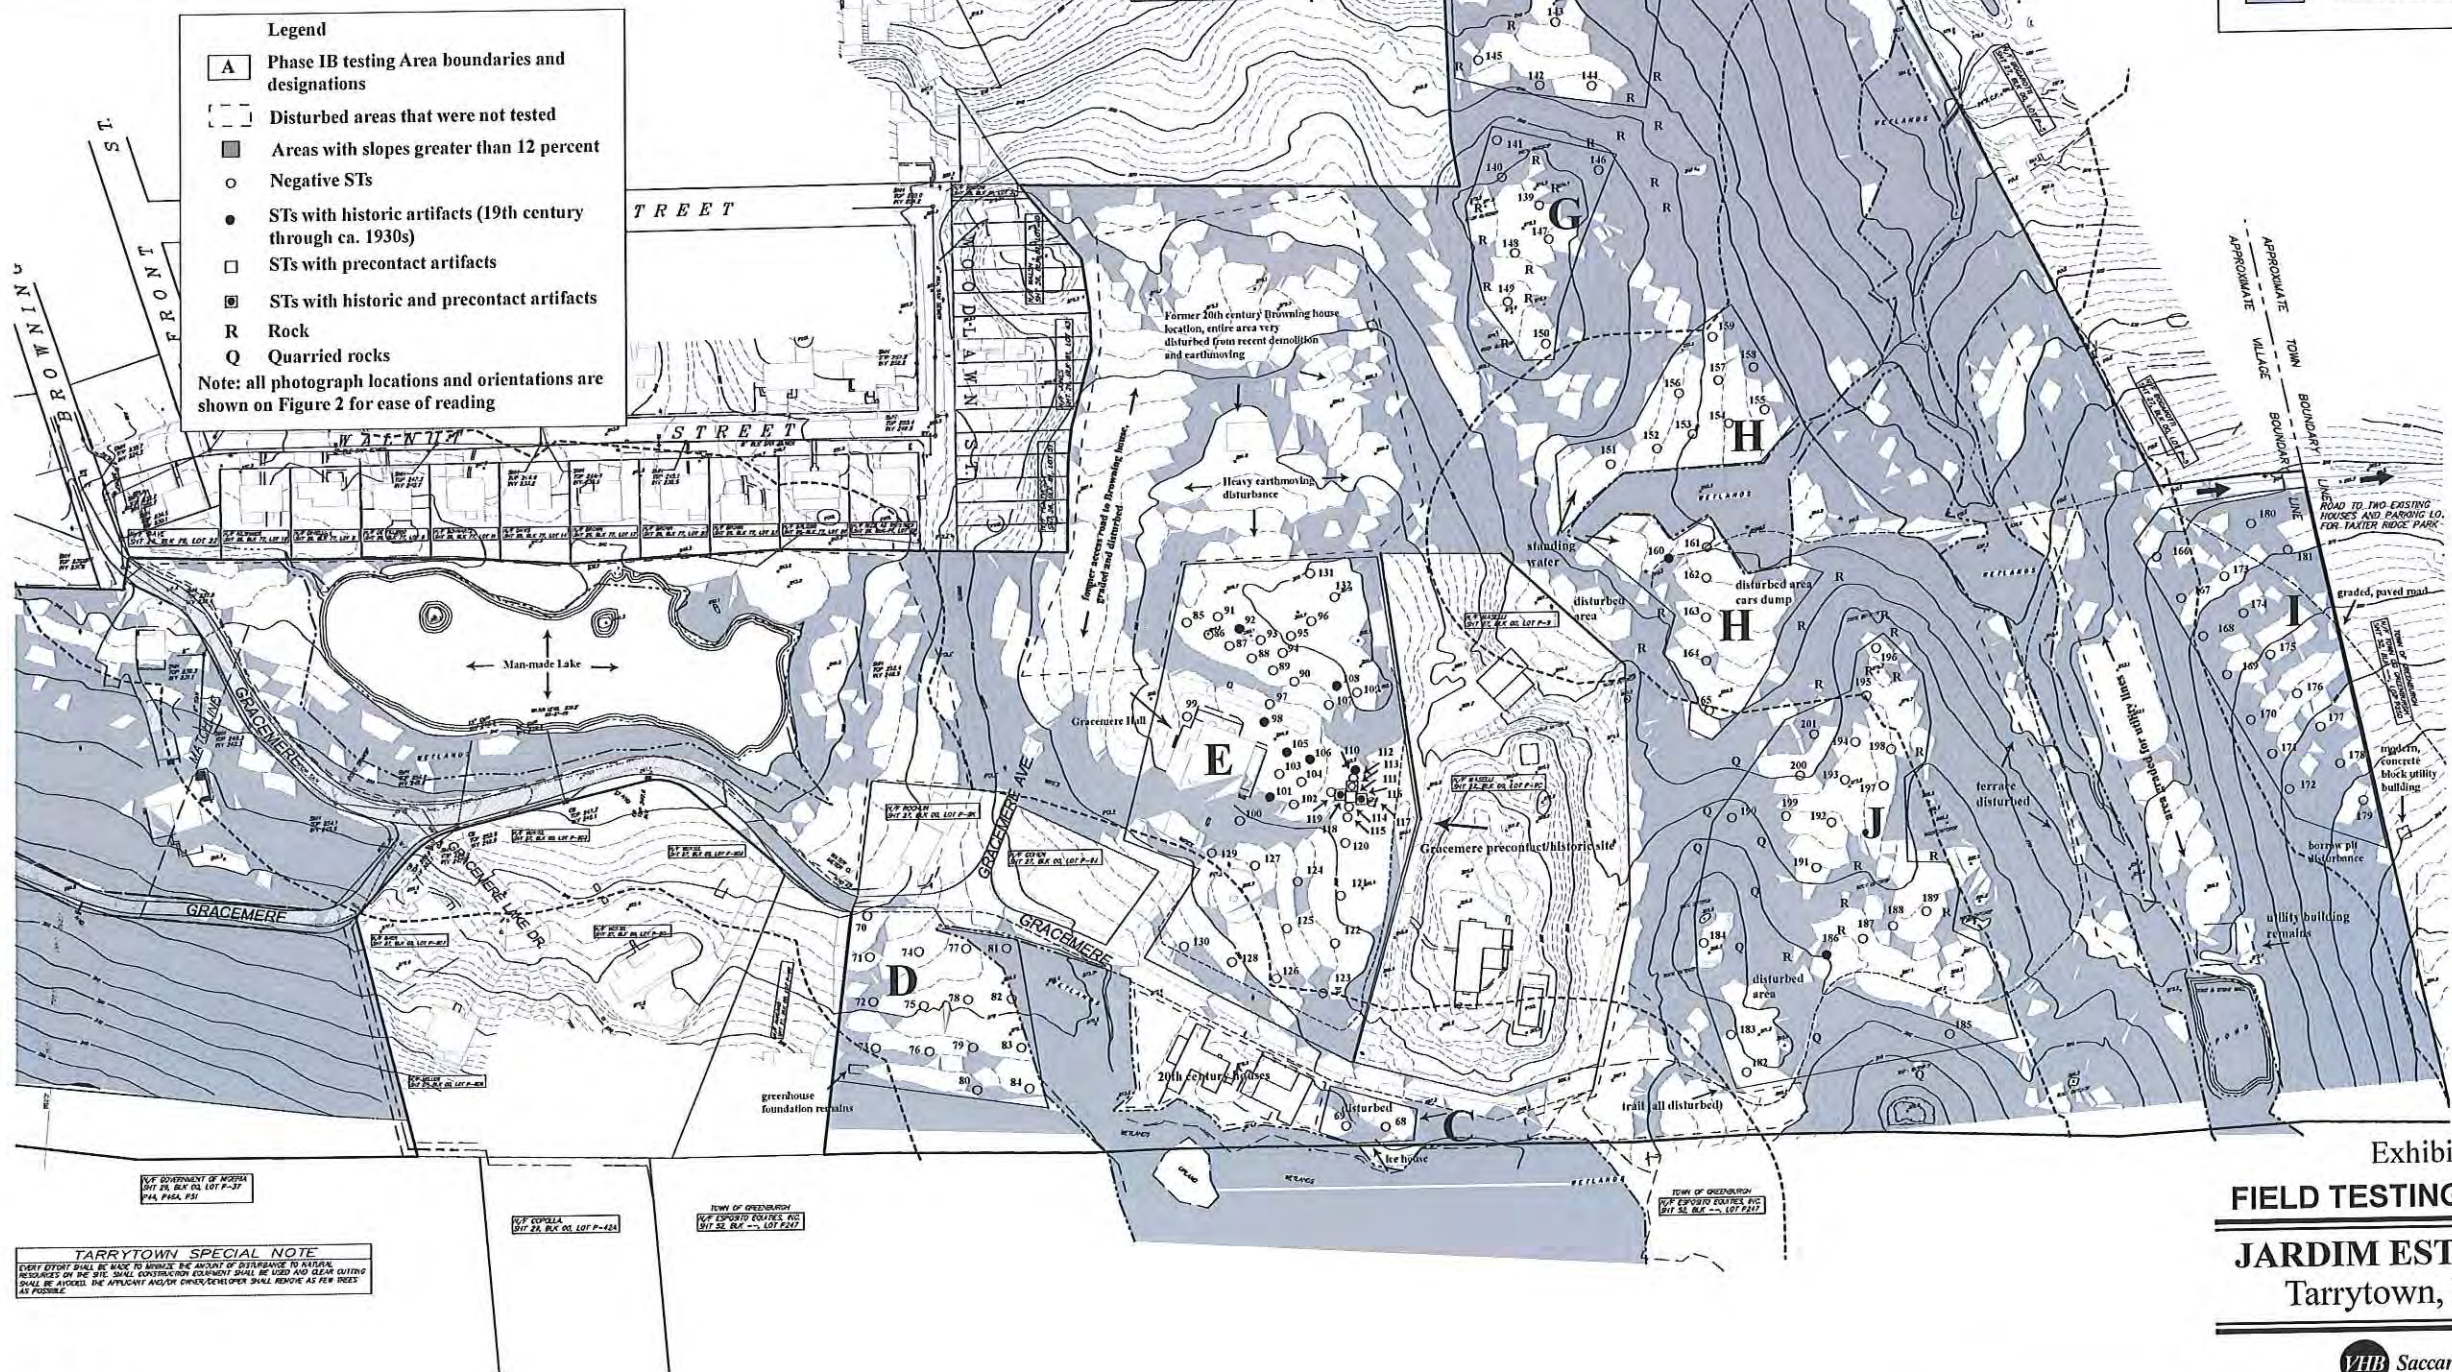
Exhibit 4-2
FIELD TESTING LOCATIONS
JARDIM ESTATES EAST
Tarrytown, New York

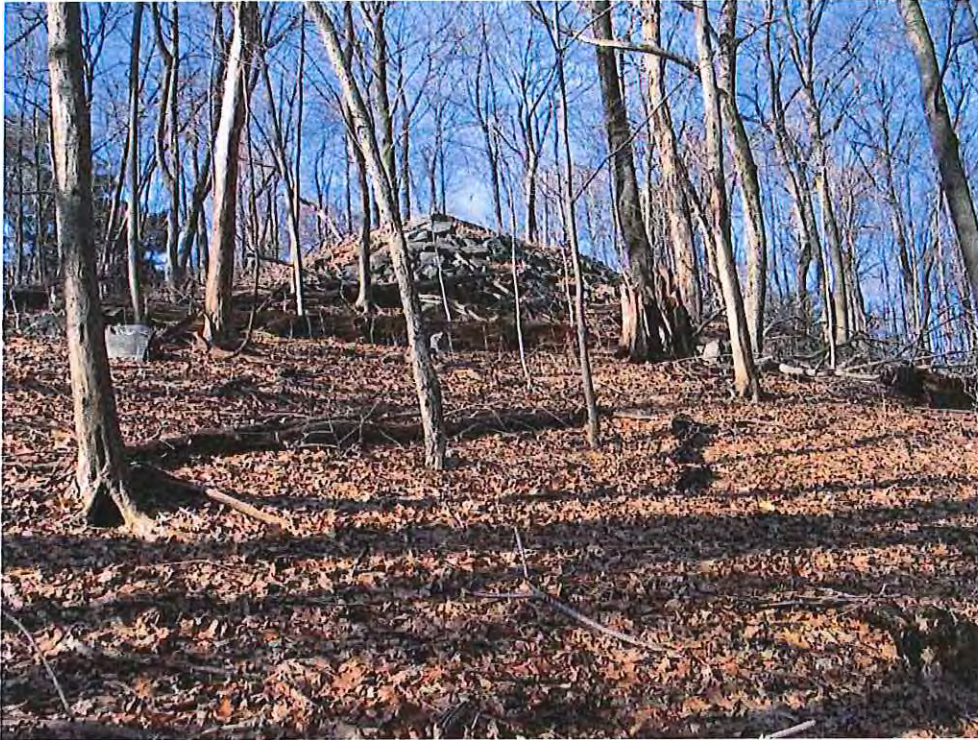
Photograph 1: Southwest corner of project site, showing steep slopes leading to large stone reservoir on hilltop. View looking southwest from roadway.

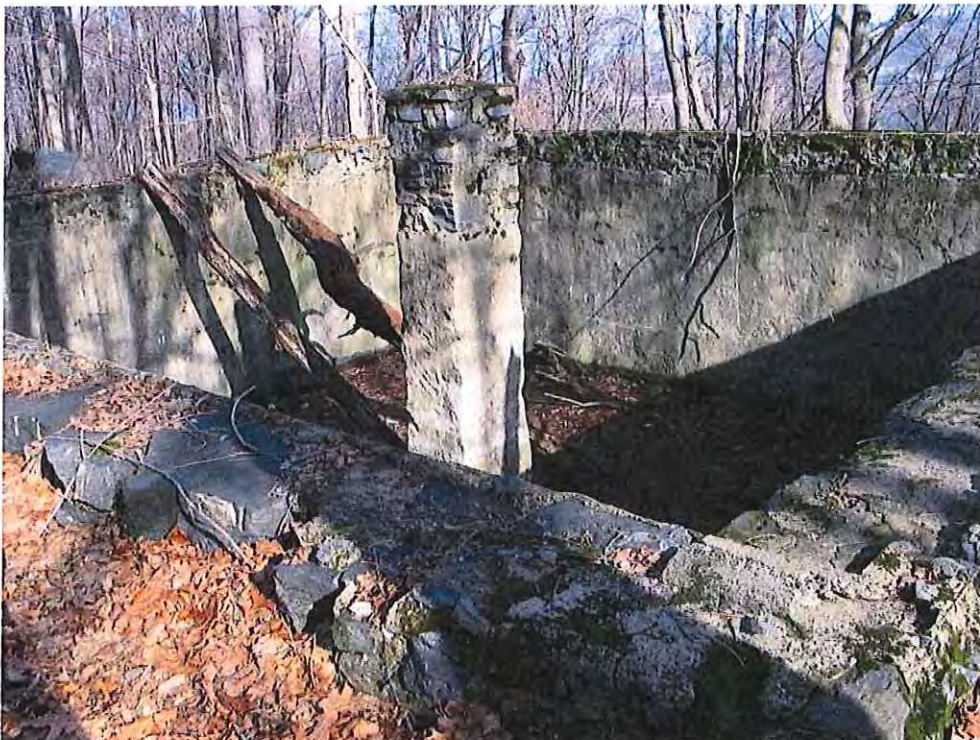
Photograph 2: Stone reservoir on top of hill at southwest corner of project site. View looking north from edge of reservoir.

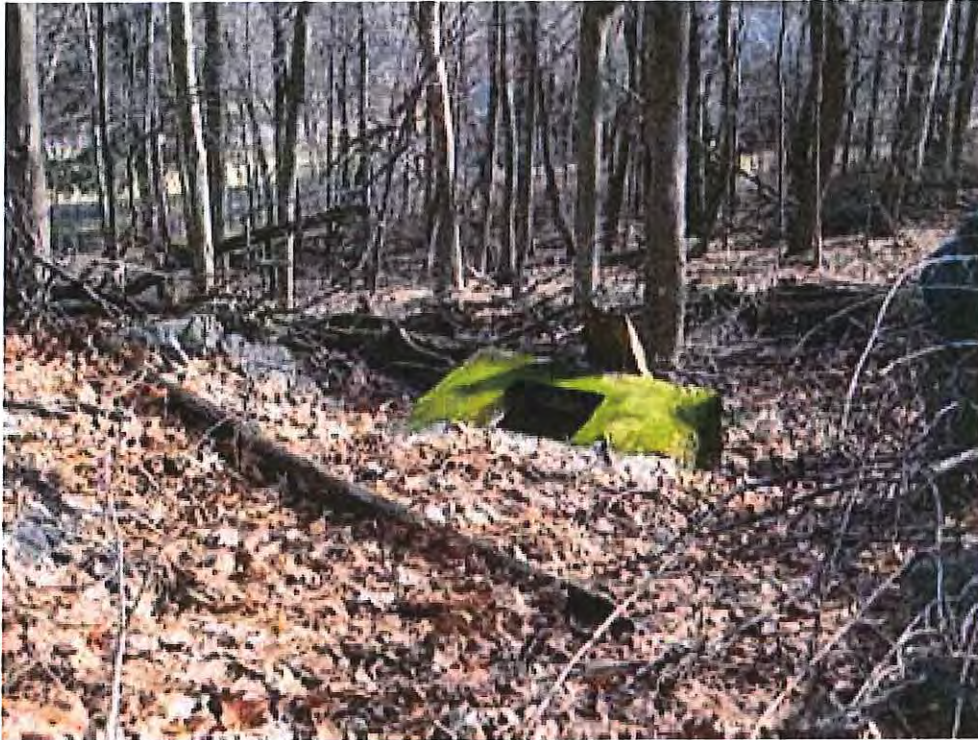
Photograph 3: Square pumping chamber on east side of stone reservoir at southwest corner of project site. View looking northeast from edge of reservoir.

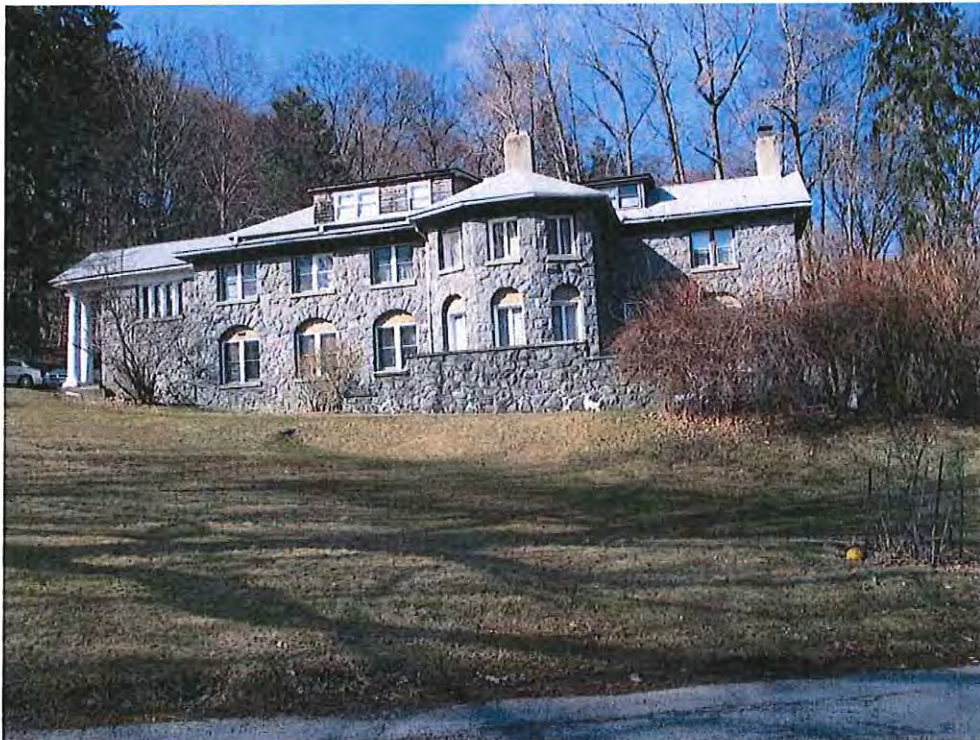
Photograph 4: Eastern (front) façade of “Gracemere Lodge” at western end of project site. View looking west from roadway.

To the north of the parcel containing the steep hillside and the reservoir is a lot containing two residences. The larger residence, known as "Gracemere Lodge," is a Colonial Revival style building which dates to the 1910s. It is an L-shaped, fieldstone-faced building, measuring 2 ½ to 3 stories with a basement (Photographs 4-7). The front façade of the building faces east, toward the lake. The building has been extensively renovated, including replacing the original windows, adding dormers along the roofline, replacing the roof, and relining the exterior of the chimneys. By the mid-twentieth century the house had been converted into apartments. The grounds surrounding this building consist of a landscaped front lawn, and an overgrown area on the west. There is an above ground fuel tank at the northwest corner of the building.

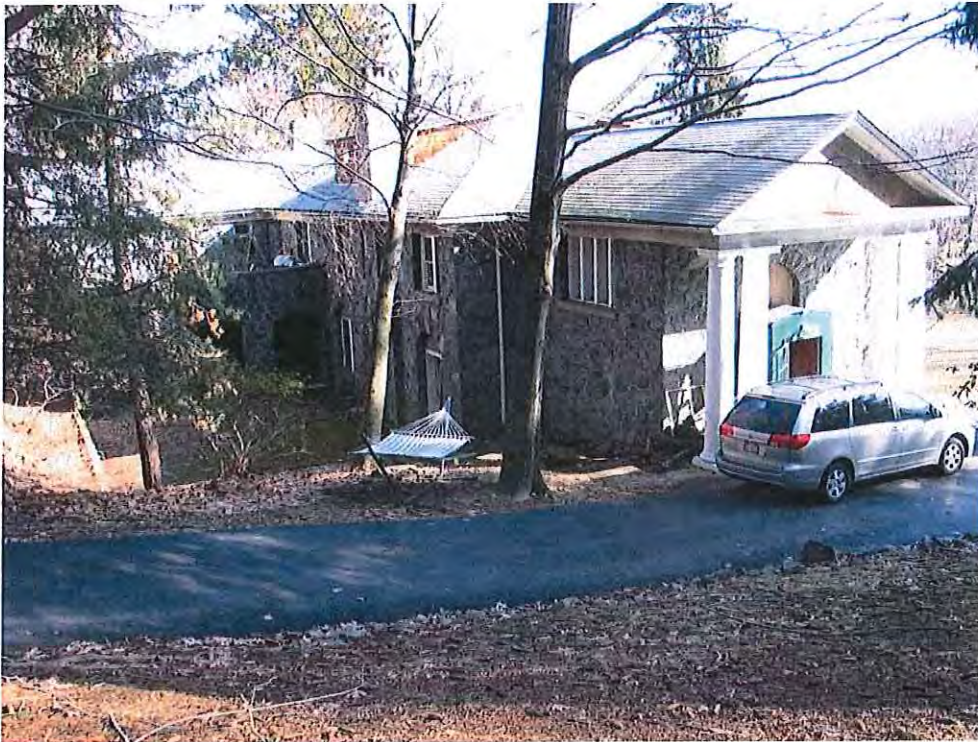
Photograph 5: Southern (side) façade of "Gracemere Lodge" at western end of project site. View looking northeast from roadway.

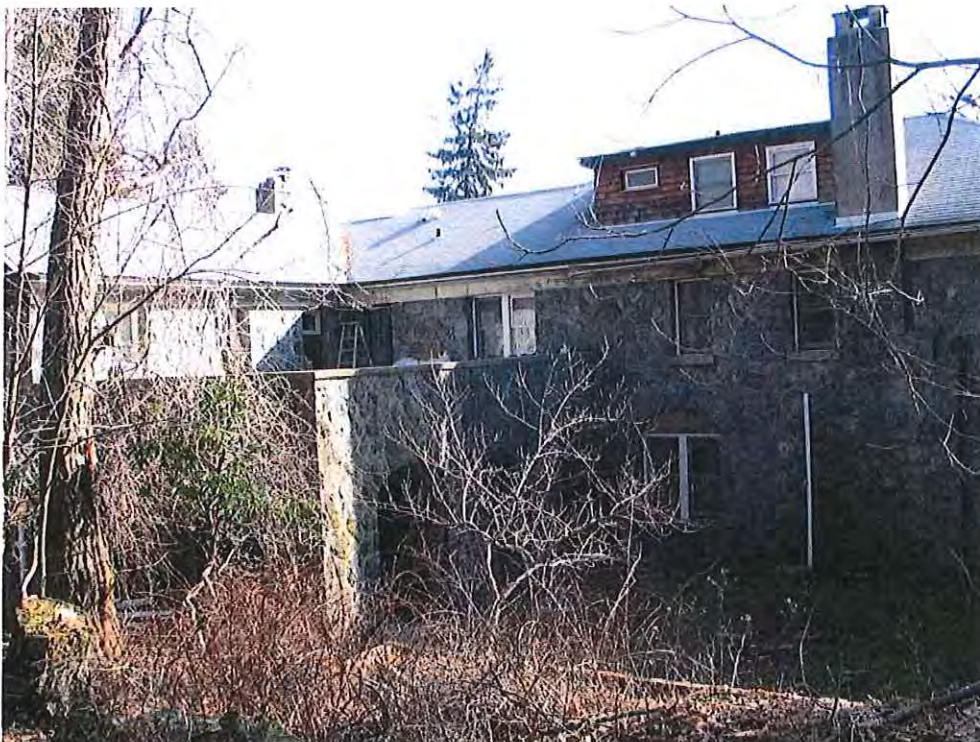
Photograph 6: Western (rear) façade of "Gracemere Lodge" at western end of project site. View looking northeast from rear of house.

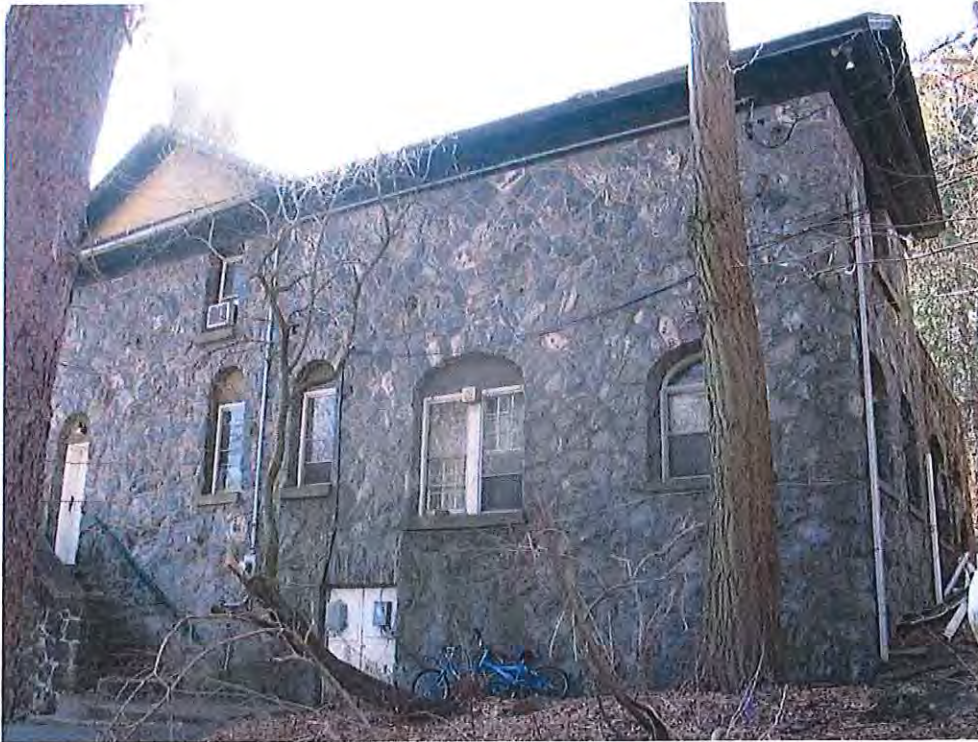
Photograph 7: North (side) façade of "Gracemere Lodge" at western end of project site. View looking south from side yard of house.

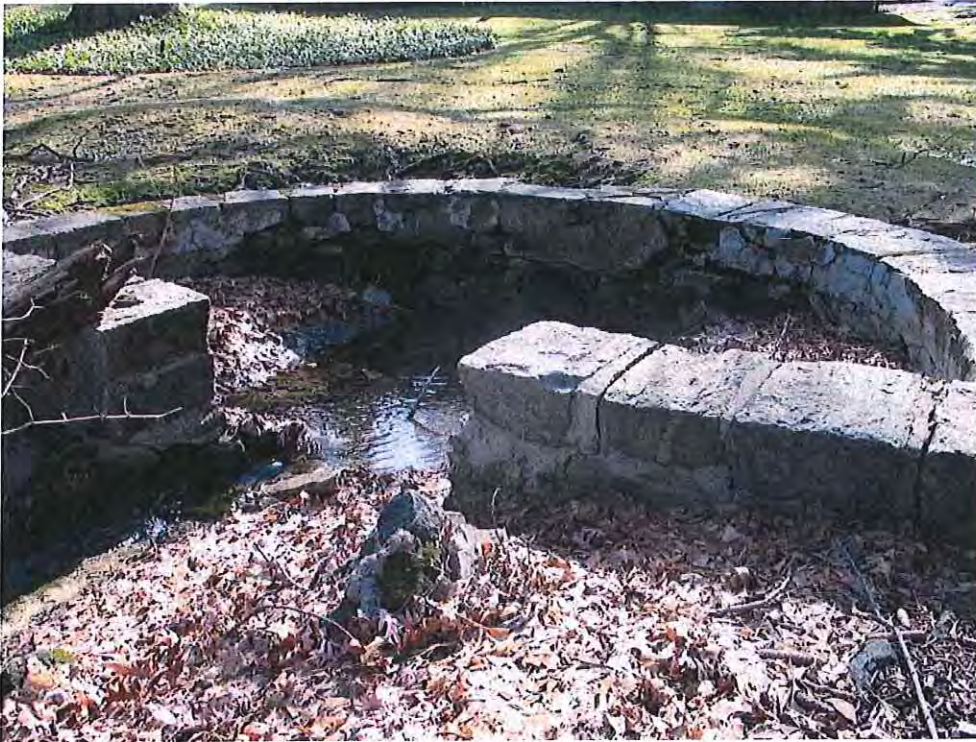
Photograph 13: Stone semicircular basin set into ground and channeling water from drainage towards “Gracemere Lake.” View looking southeast from near southeastern edge of lake.

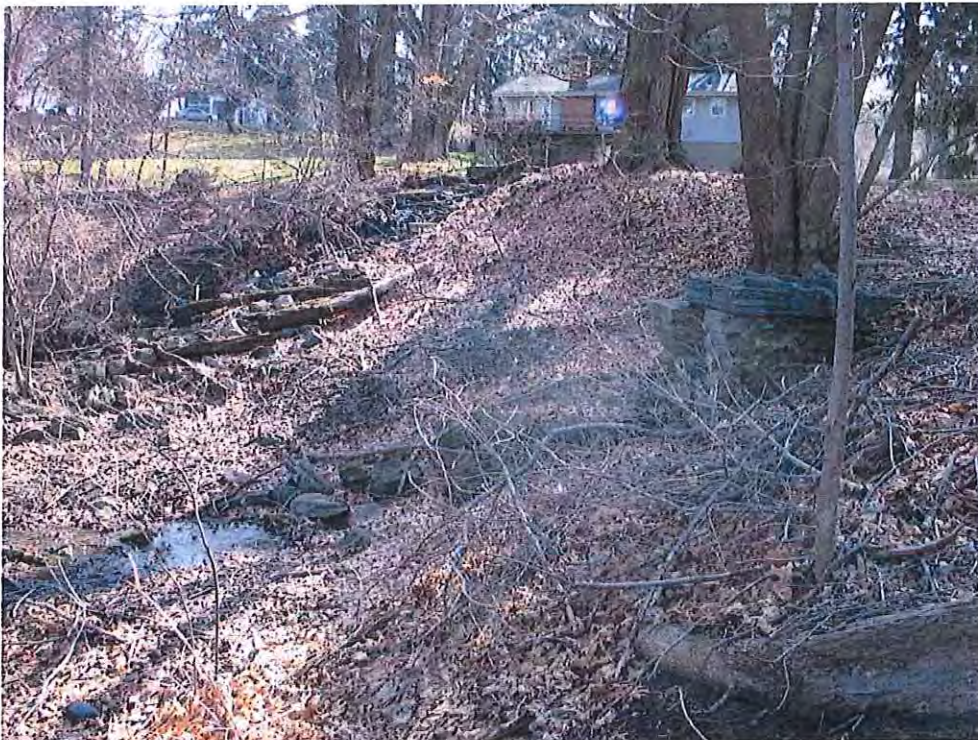
Photograph 14: Southeastern edge of “Gracemere Lake” showing two water channels running down the hill into the lake. House in right background is off the project site. View looking southeast from near southeastern edge of lake.

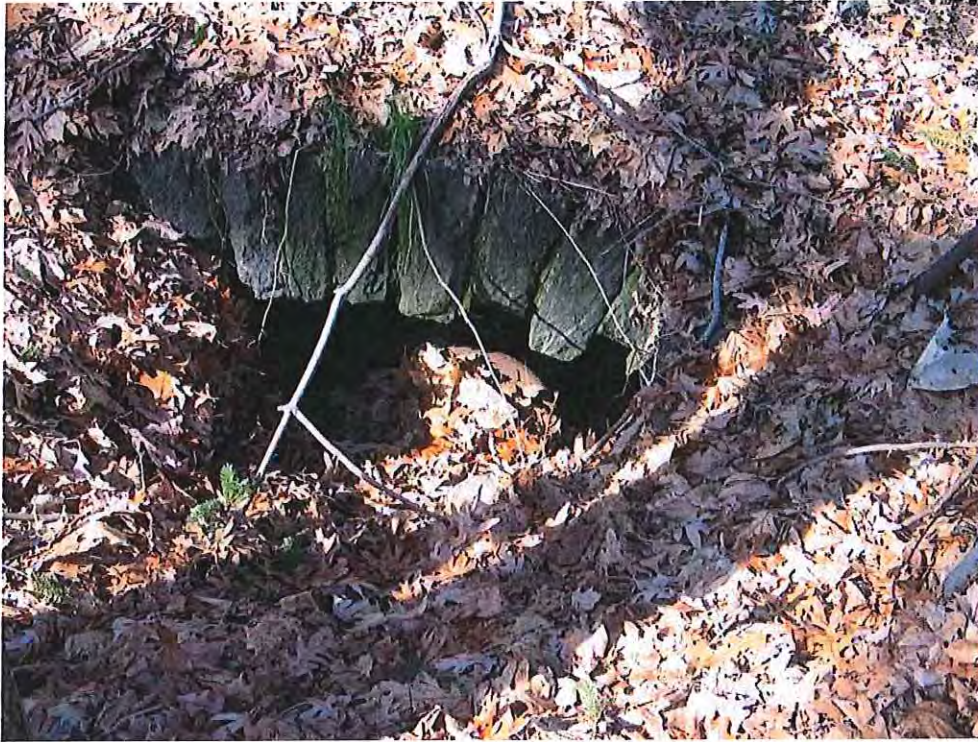
Photograph 15: Small stone arched walkway or “bridge,” which may overlay one of the pipes leading to “Gracemere Lake.” View looking northwest from near southeastern edge of lake.

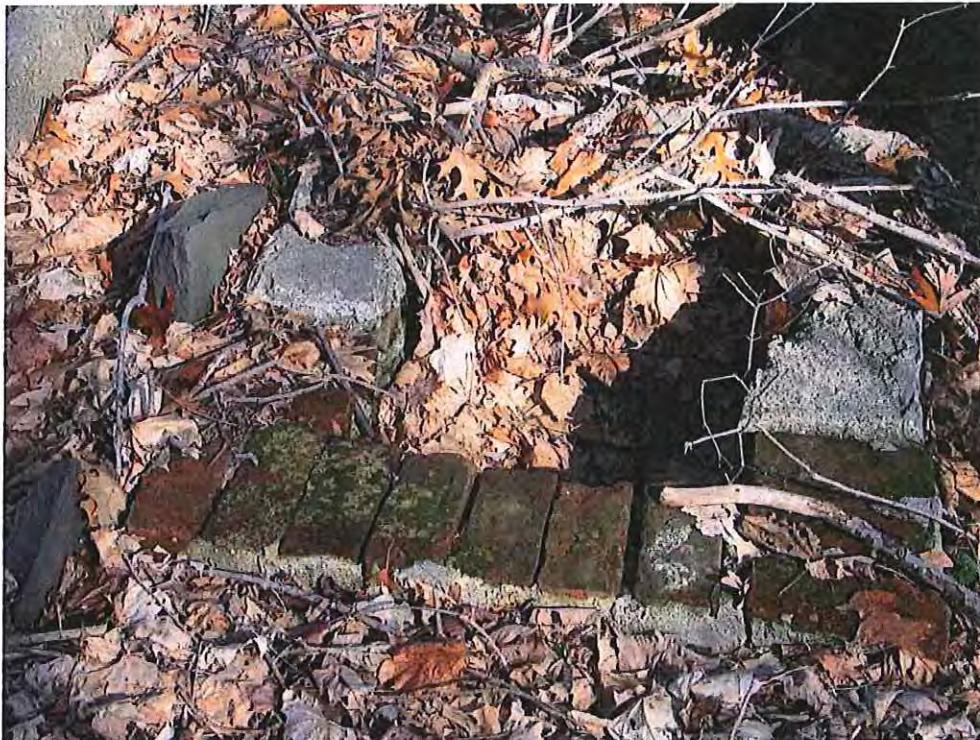
Photograph 16: Small, rectangular shaped brick chamber, possibly a dry well, located northeast of stone arch shown in previous photograph. View looking northwest from near southeastern edge of lake.

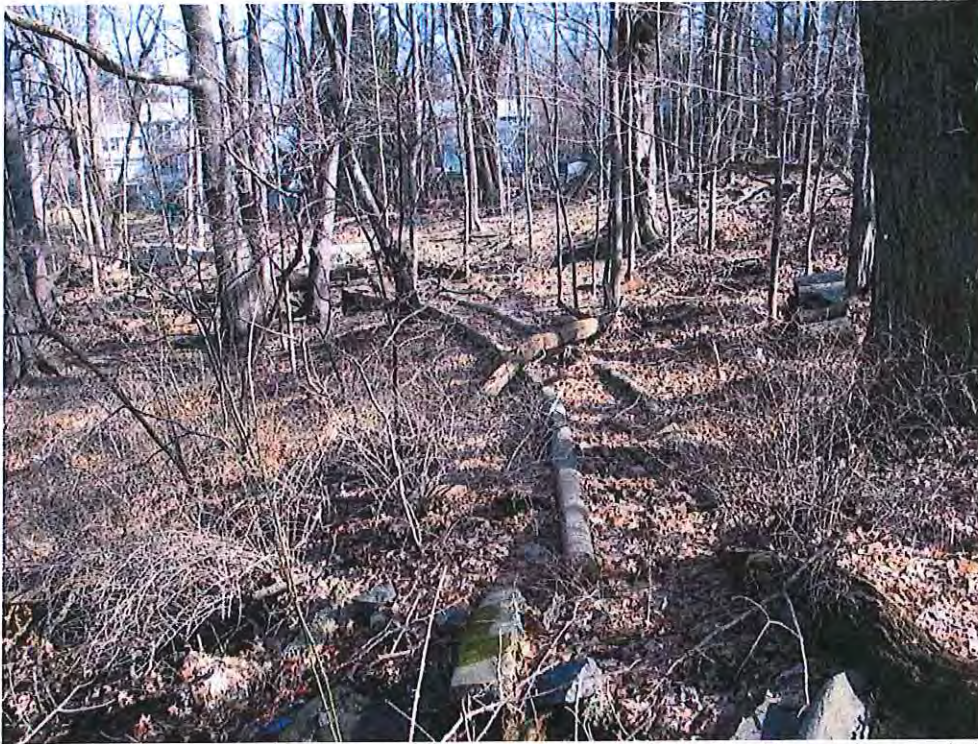
Photograph 17: Concrete lined channel running along the east side of the lake to a large oval-shaped fieldstone and concrete lined feature, in left background. View looking northeast from near southeastern edge of lake.

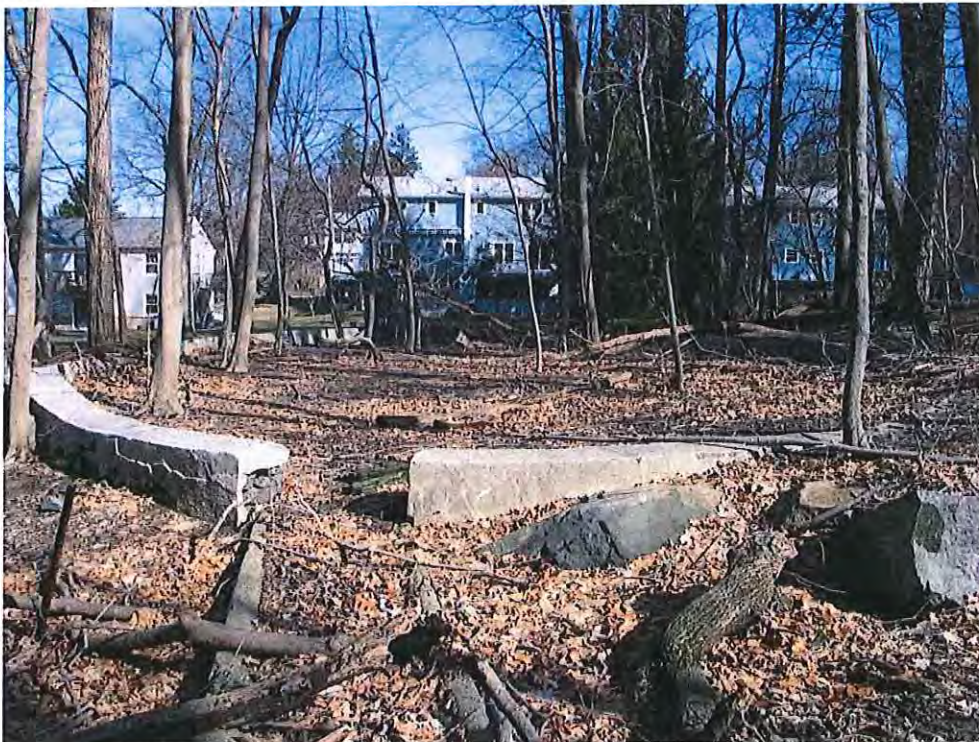
Photograph 18: Large oval-shaped fieldstone and concrete lined feature, which appears to have drained into the lake. Concrete channel shown in previous photograph is in the foreground. View looking northeast from near southeastern edge of lake.

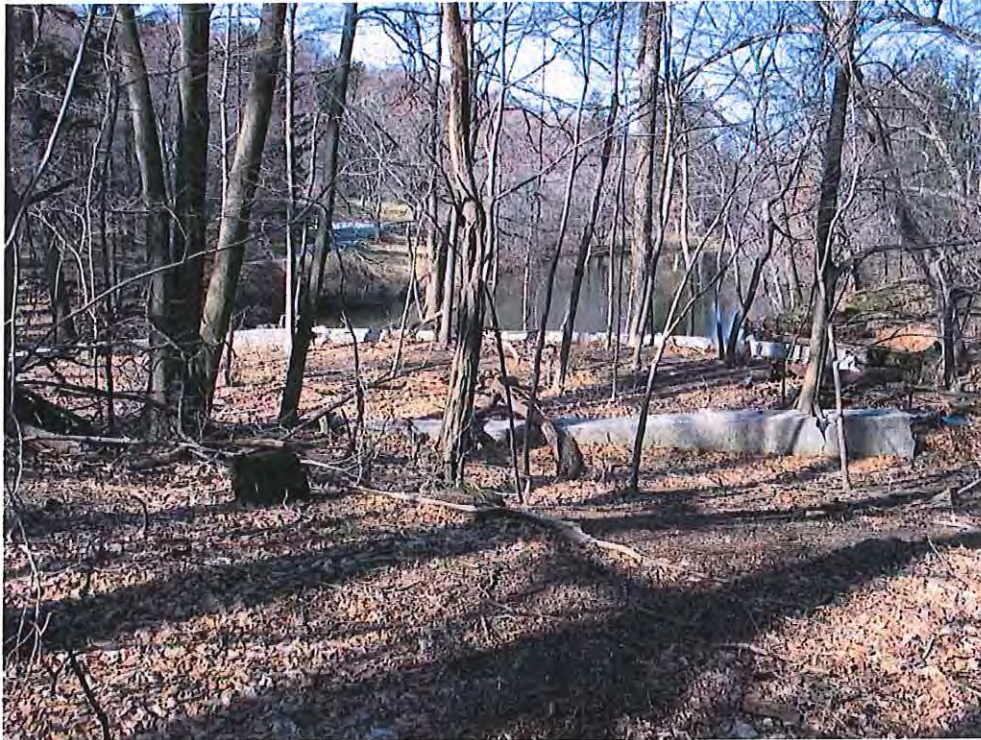
Photograph 19: View of large oval-shaped fieldstone and concrete lined feature in previous photograph, showing relationship to lake. View looking northwest from area east of the lake.

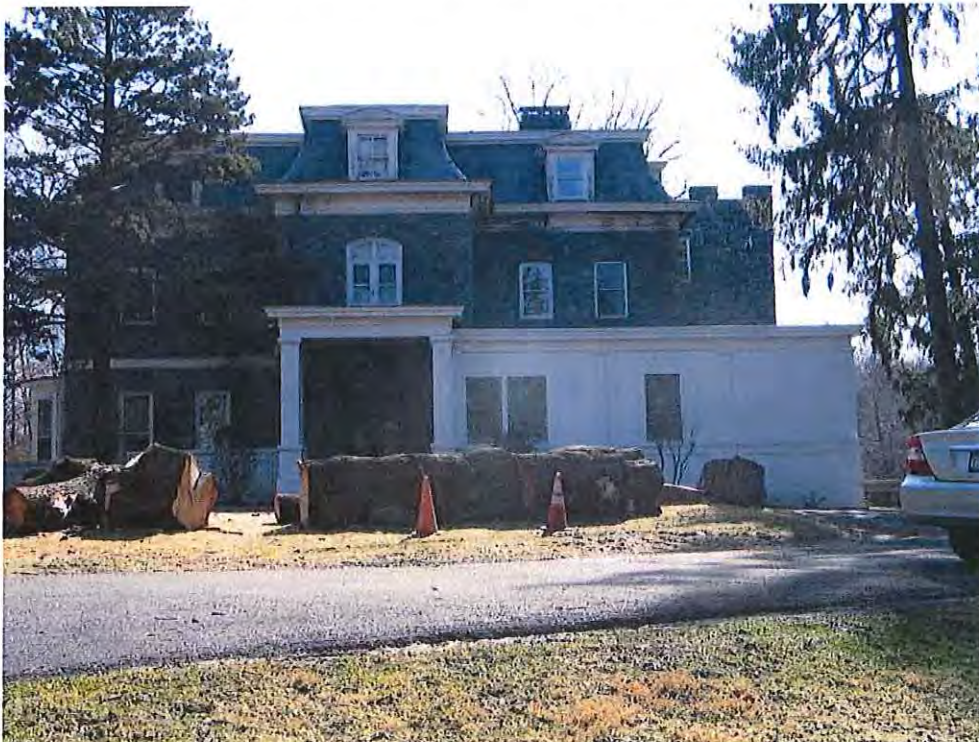
Photograph 22: Northwest (front) façade of "Gracemere Hall," the original French Second-Empire style mansion house built on the project site. View looking southeast.

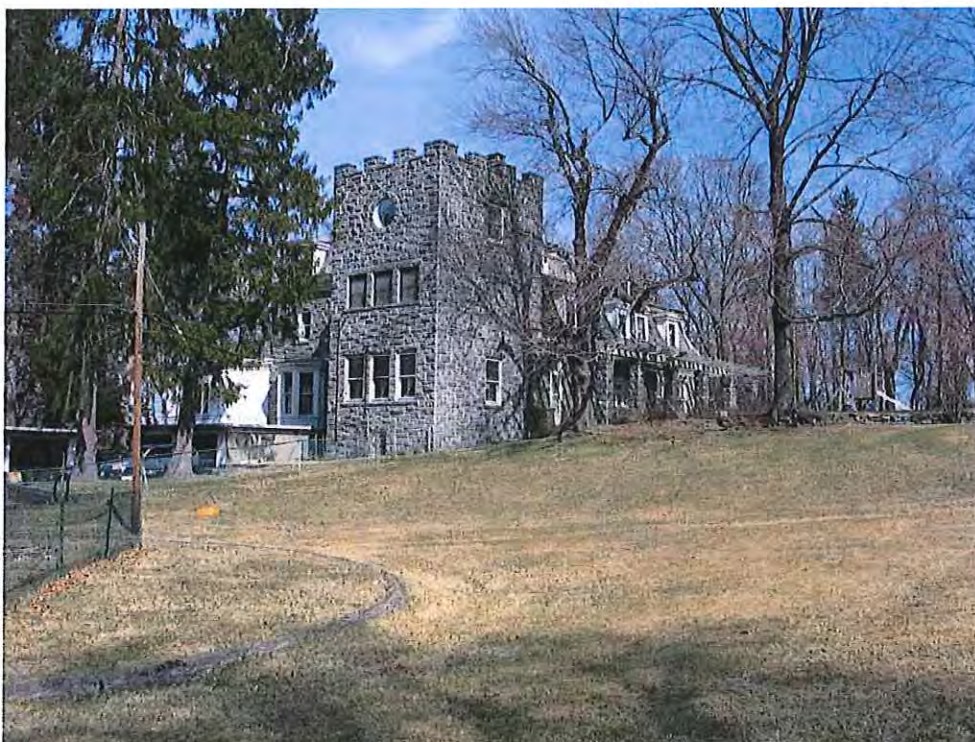
Photograph 24: Southeast and southwest (side and rear) façades of "Gracemere Hall," with landscaped grounds in foreground. Note tower on building's southern corner. View looking north.

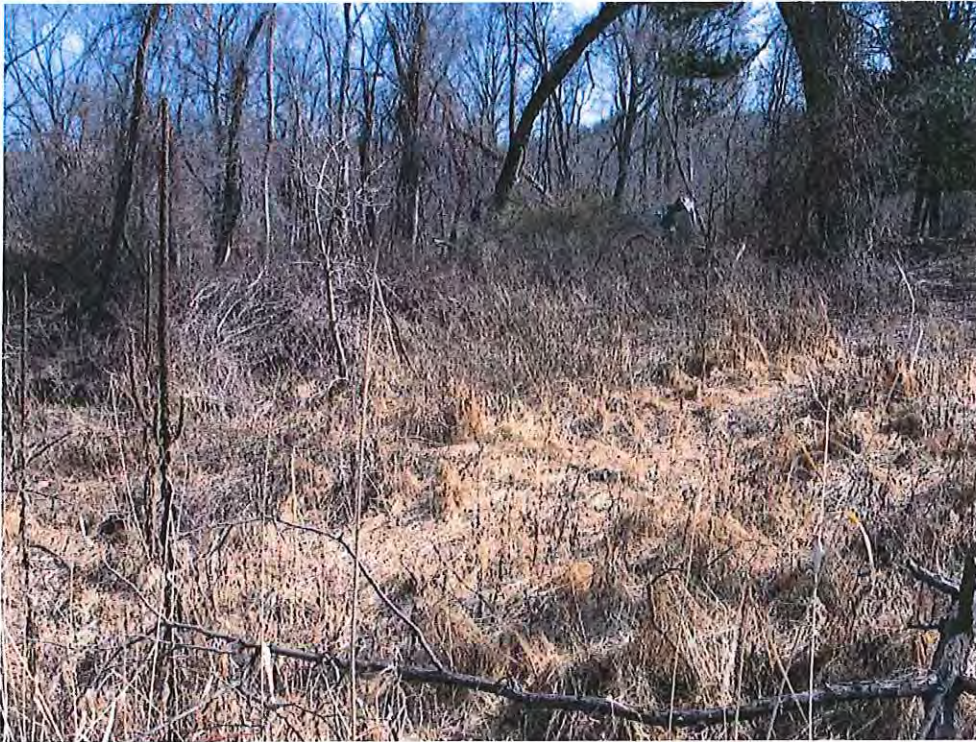
Photograph 27: Former location of Browning mansion, demolished in 2005. Note extensive disturbance to entire area. View looking northeast.

North of the Gracemere Hall parcel is a property formerly part of the Gracemere holdings that until ca. 2005 contained another mansion house. The rectangular-shaped house was built in the Colonial Revival style, and had a gambrel roof with pedimented dormers (Yasinac 2000). The field inspection revealed that the demolition process in ca. 2005 has rendered the former location of this house, as well as the remainder of this parcel, extensively disturbed. No evidence of any intact portion of the former house foundation was visible or observed. Instead, large fragments of stone and bricks were noted in churned up piles. Only a portion of a former addition or outbuilding was still present. The extensive surface examination of this location found that the ground surface within the entire parcel was completely disturbed by the large-scale demolition of the structures by heavy machinery.

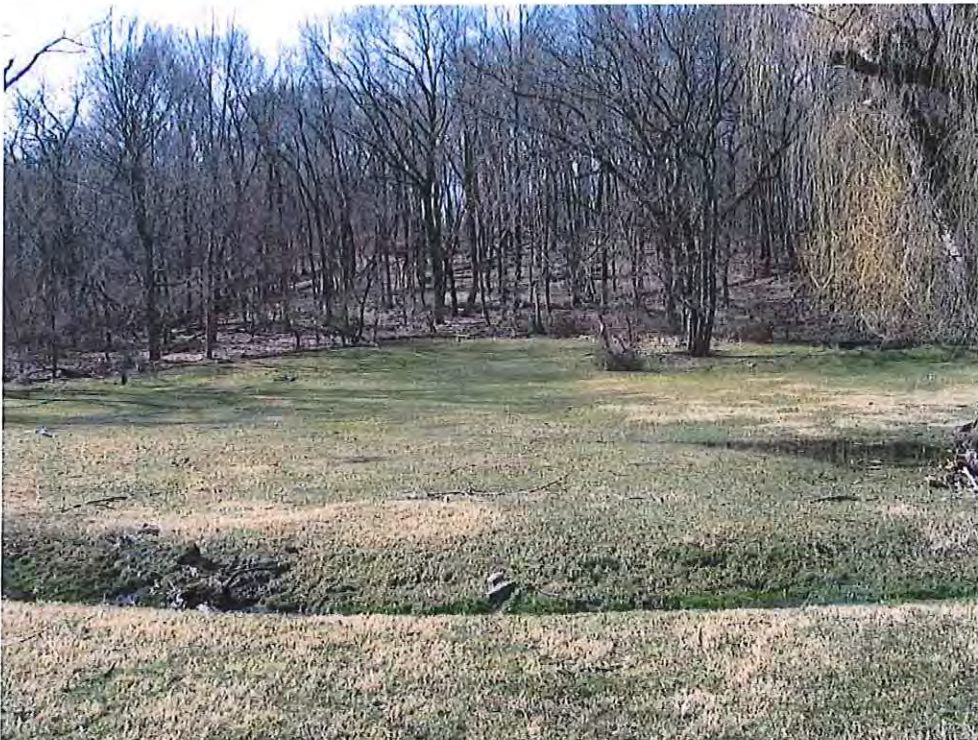
Photograph 28: Land southwest of Gracemere roadway containing a channelized trough containing the drainage that feeds "Gracemere Lake" bordering the roadway. Note wetland on right. View looking southwest from Gracemere roadway.

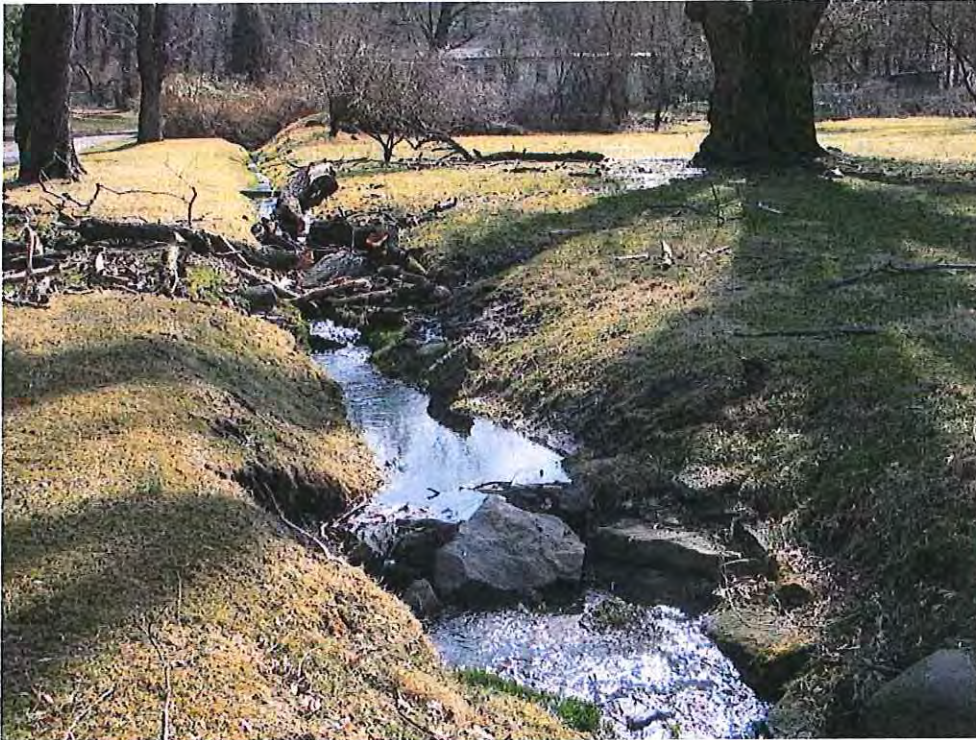
Photograph 29: Second view of channelized trough containing the drainage that feeds "Gracemere Lake." "Gracemere Court" is in far background. View looking southeast.

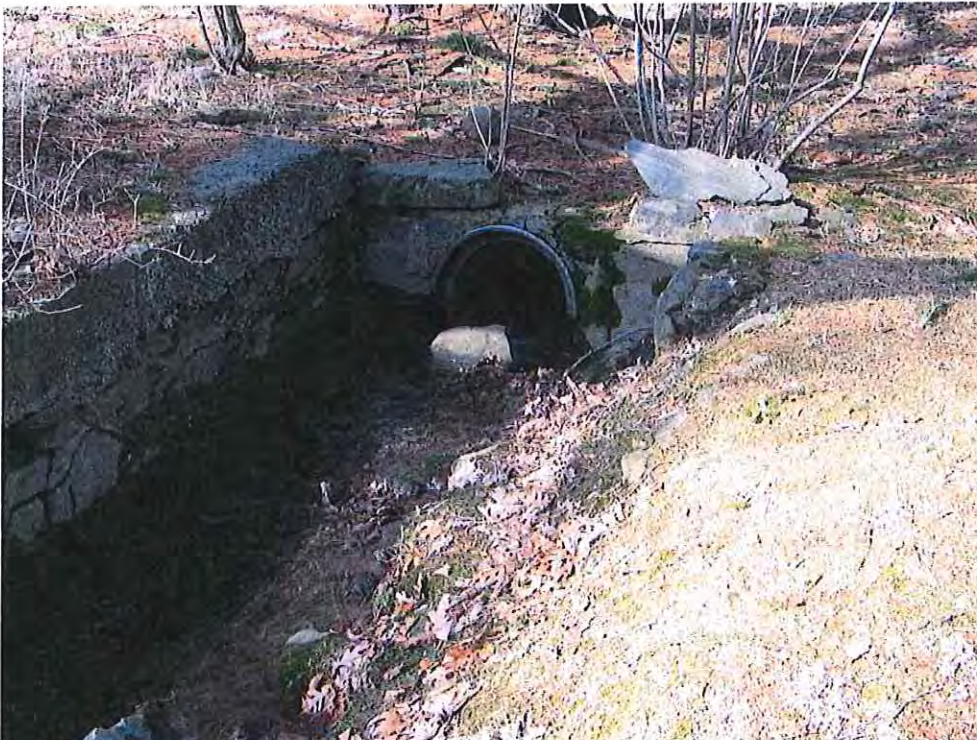
Photograph 30: Culvert carrying channelized trough under Gracemere roadway to the lake. View looking northwest.

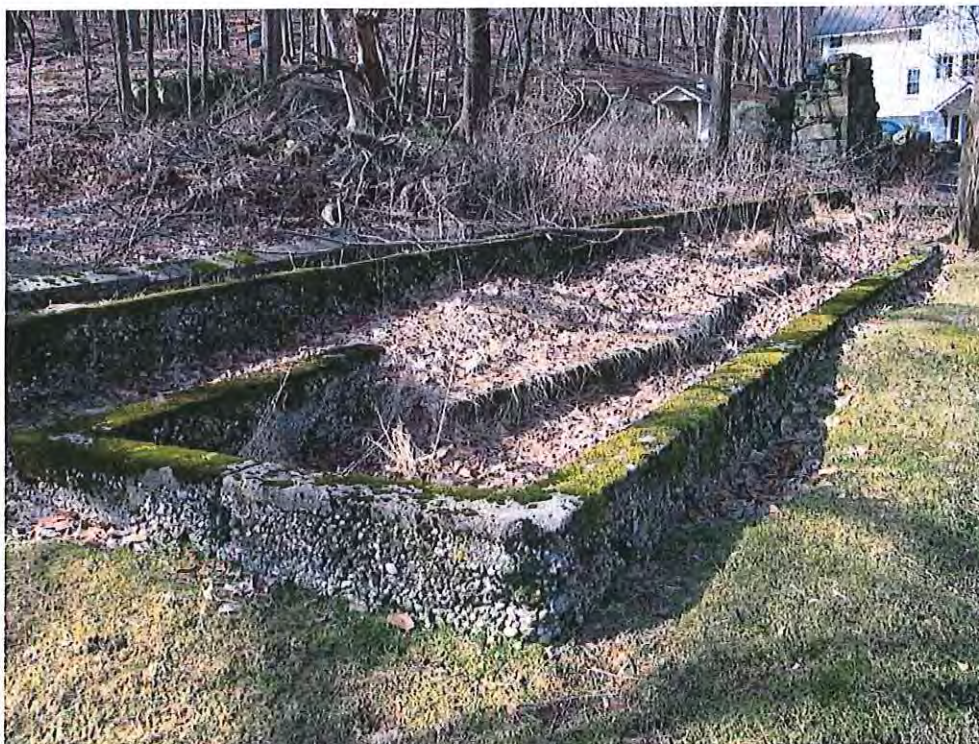
Photograph 32: Stone foundation remains of a greenhouse, located near southern edge of project site. View looking west.

South of the Gracemere Hall parcel is a thin strip of land bounded on the north by a paved roadway and on the south by the Tarrytown village line. The stream that feeds the lake has been moved and altered to such a degree that it is only visible in spots, including in a channelized trough along the southern side of the roadway, and wet areas south of the trough. The western side of this parcel is vacant land. It contains stone foundation remains of a greenhouse.

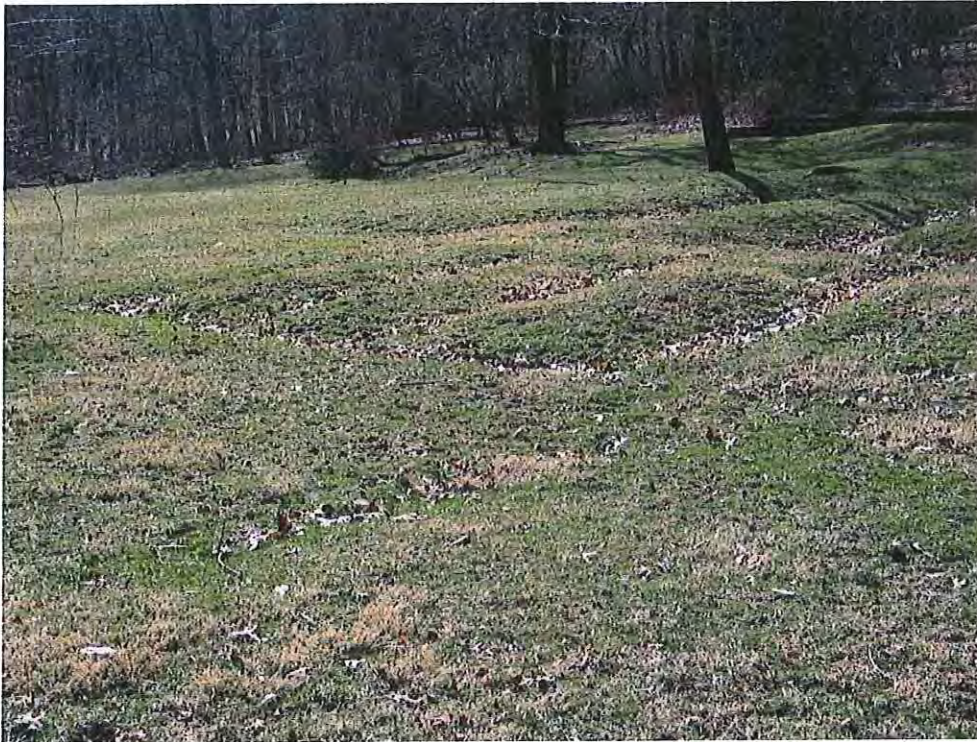
Photograph 33: Furrows in the ground that probably represent old planting beds, located east of the greenhouse remains shown in the previous photograph. View looking southwest.

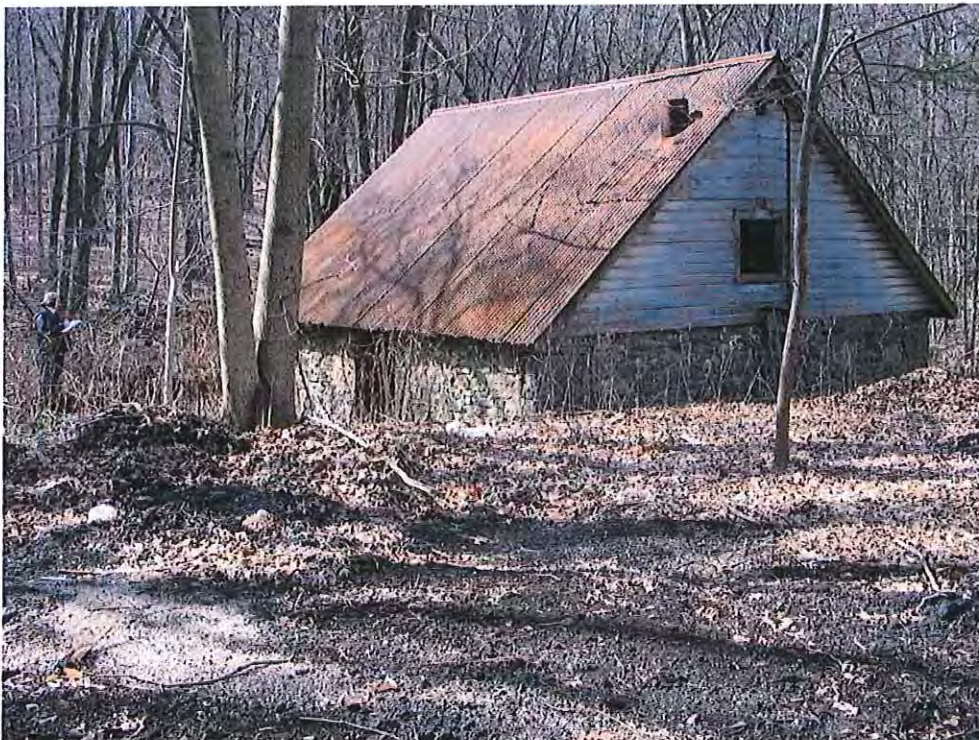
Photograph 36: North (rear) façade of ice house, located east of "Gracemere Court," and cut into the side of a hill. View looking southeast from Gracemere roadway.

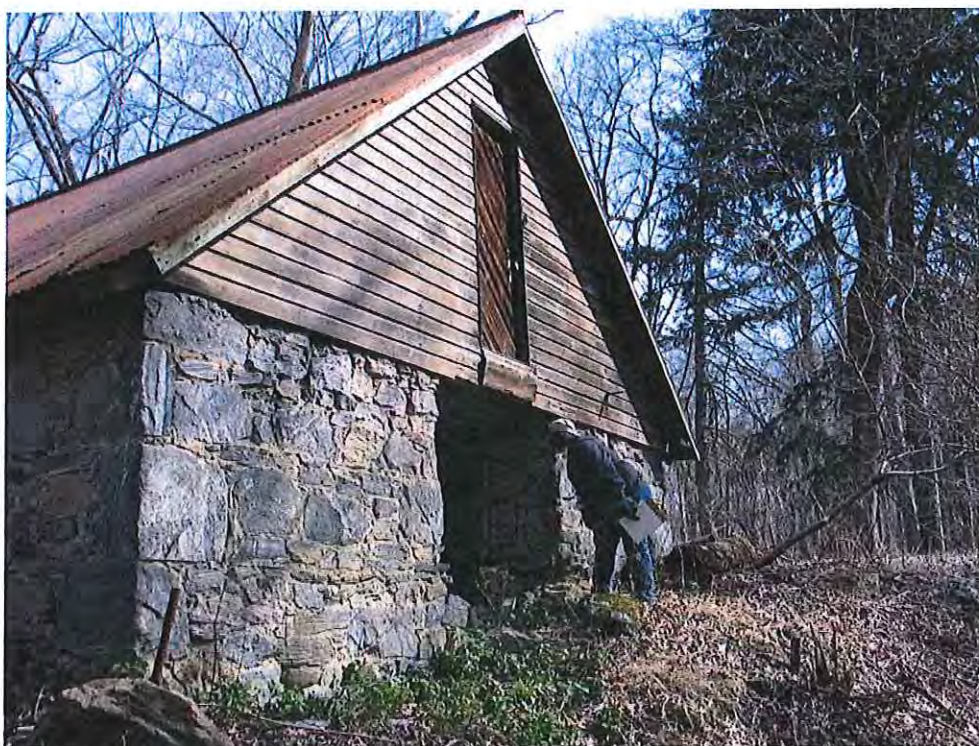
Photograph 37: South (front) façade of ice house. View looking northeast.

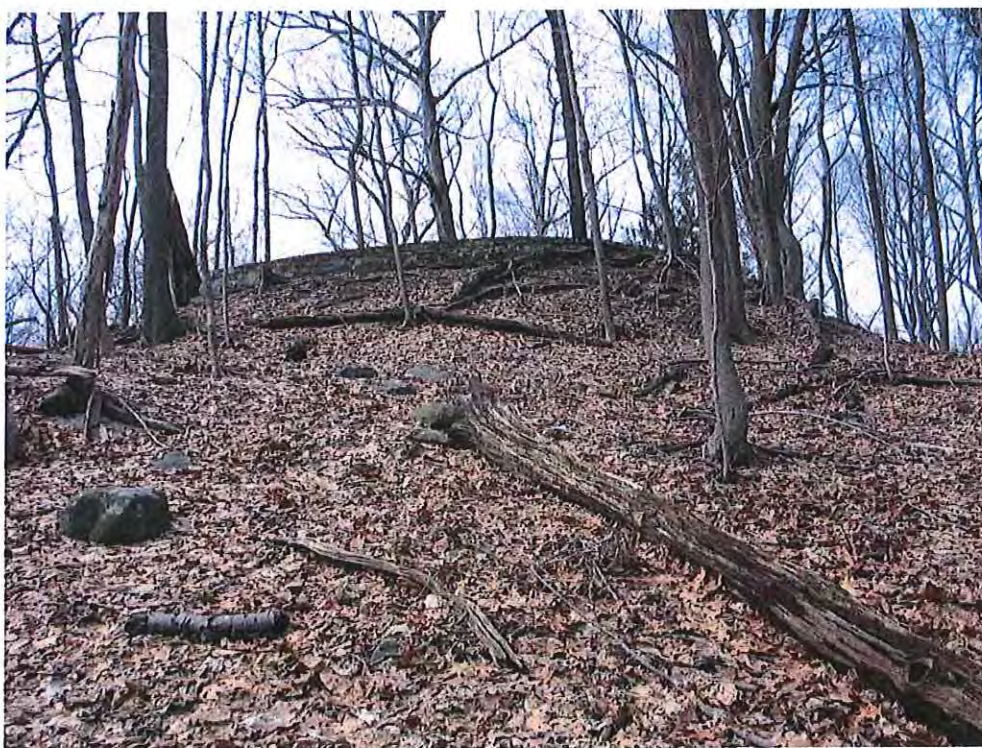
Photograph 38: Knoll containing stone and concrete lined reservoir at top. View looking east.
