4

Cultural Resources

4.1 Introduction

JARDIM ESTATES EAST
Tarrytown, New York

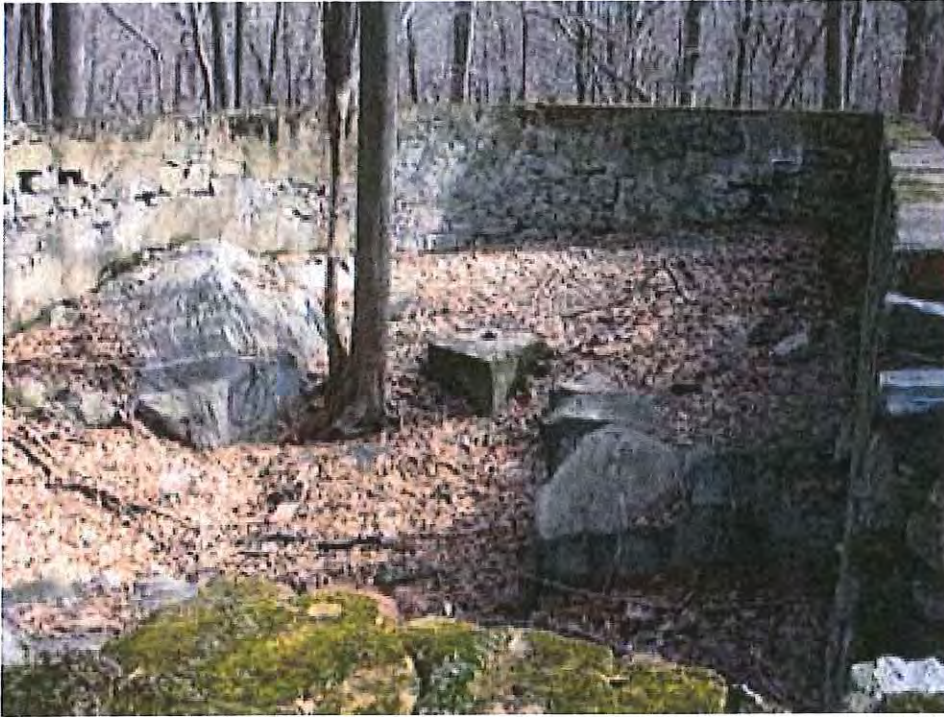
Photograph 39: Interior of stone and concrete lined reservoir shown in previous photograph. View looking east from edge of structure.

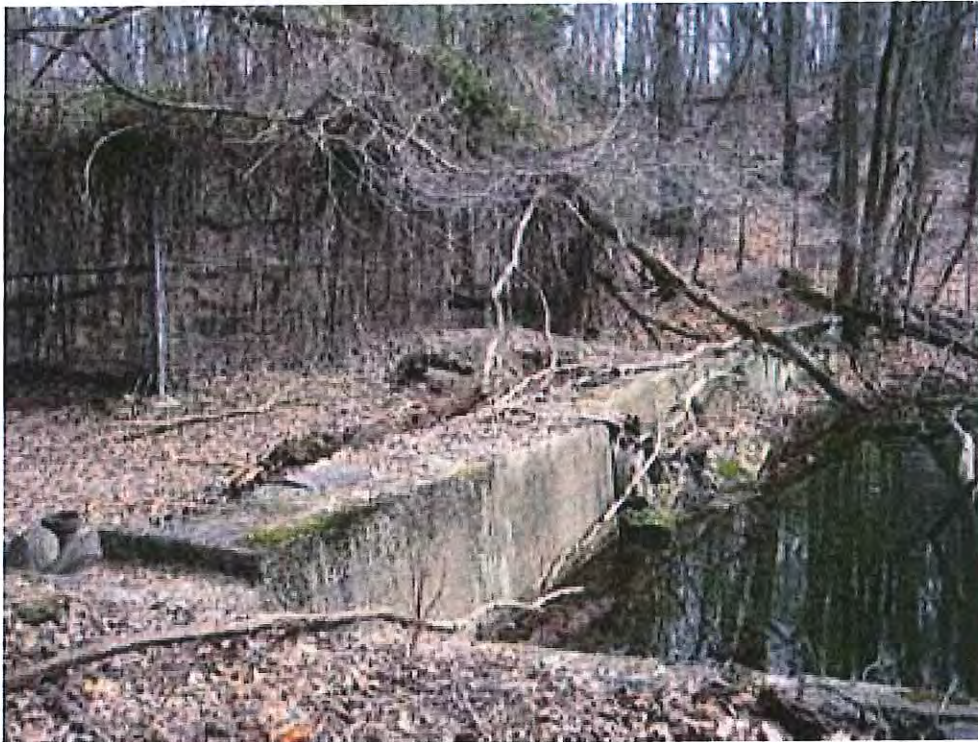
Photograph 43: Concrete dam at northern end of "Turtle Pond." View looking northeast.

There are a number of additional concrete features along the east side of the drainage. These include a possible pump house (with pipes still visible) near Turtle Pond, a stone channel and a series of spigots along the stream. A small concrete foundation remnant (surrounded by a high chain link fence) is located on the east side of the stream as well.

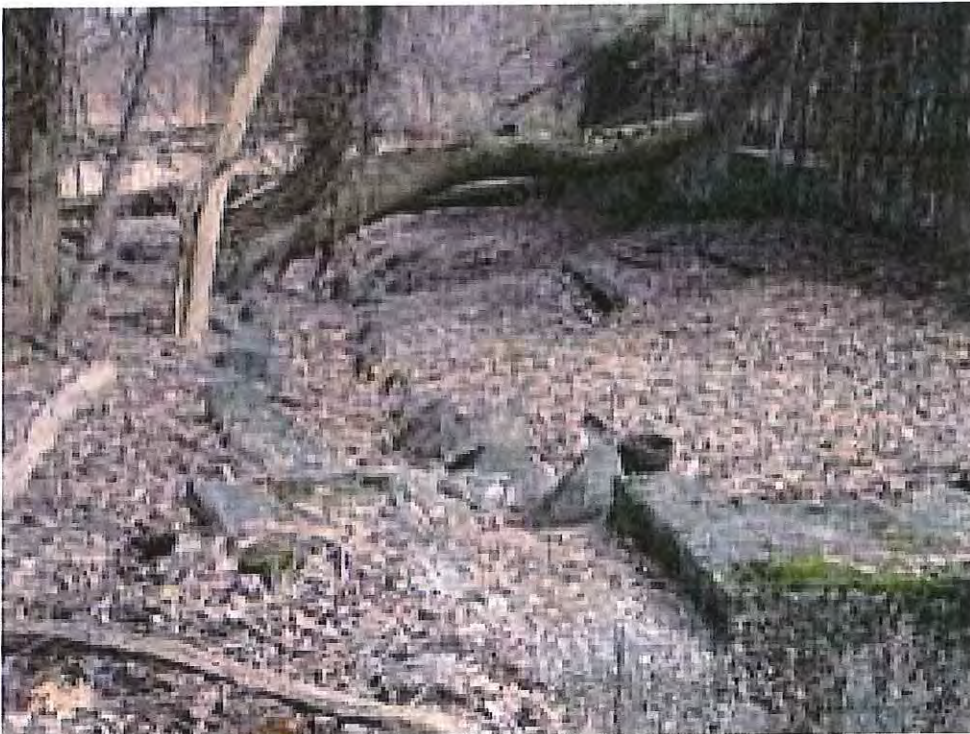
Photograph 44: Stone channel leading north from "Turtle Pond" dam. View looking northeast.

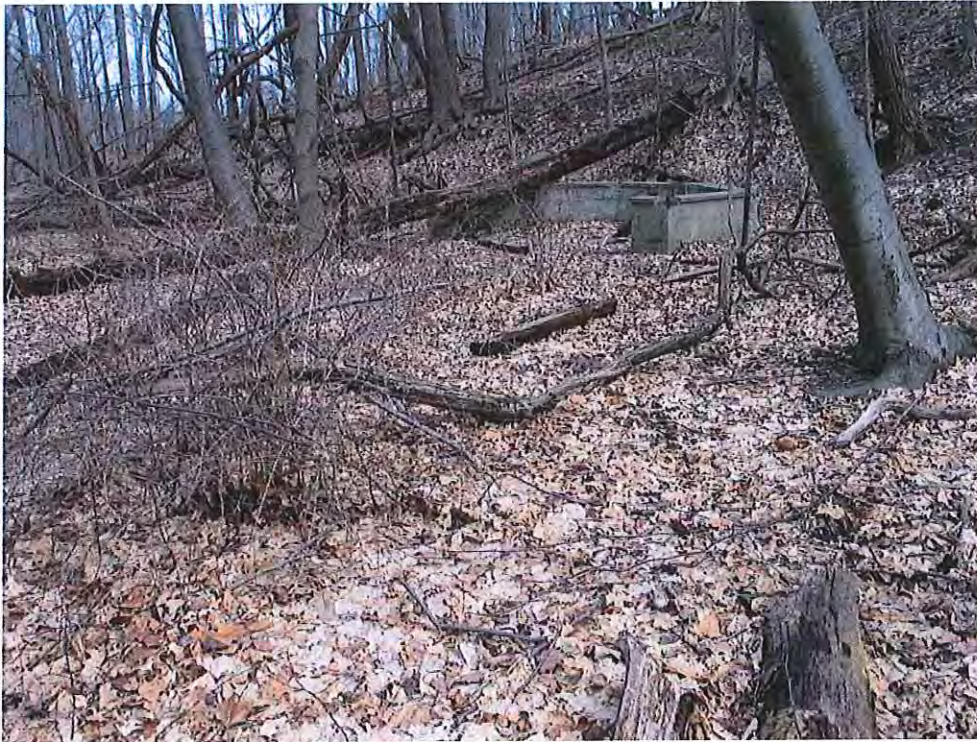
Photograph 45: Small concrete foundation remnant (surrounded by a high chain link fence) on the east side of the stream. View looking east.

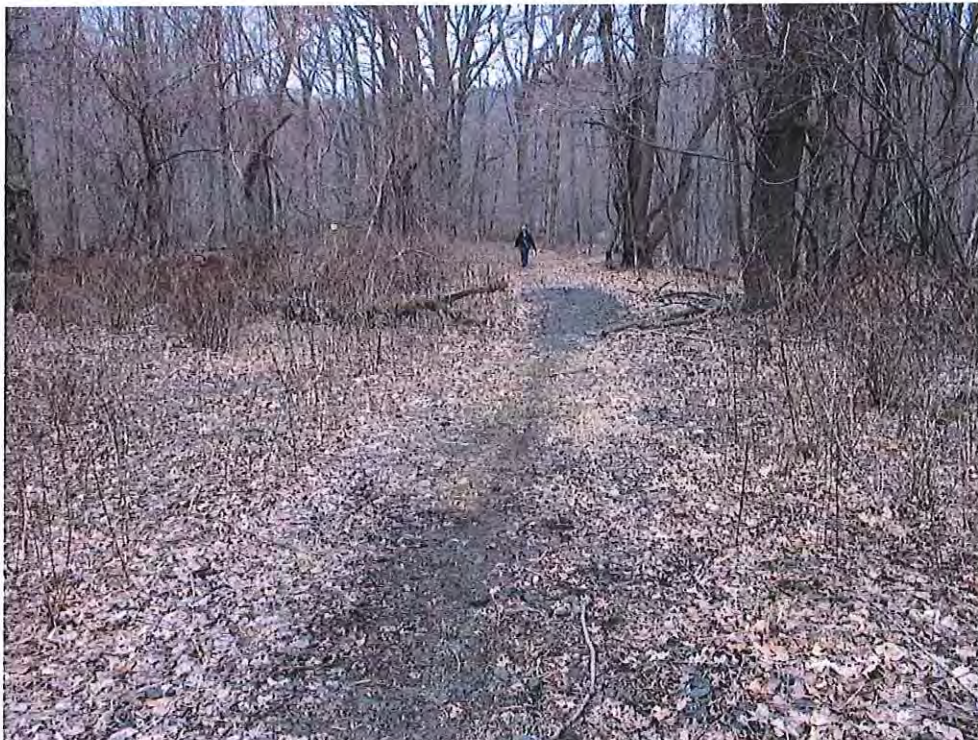
Photograph 46: Remnant of a former private driveway that led to a twentieth-century residence at the southeastern end of the project site. View looking south.

The third entry to the project site is along a right-of-way running south from Sheldon Avenue on the east side of the project site. At the end of this roadway, there is a remnant of a former private driveway that led to a twentieth-century residence. Only the concrete foundation is visible today.

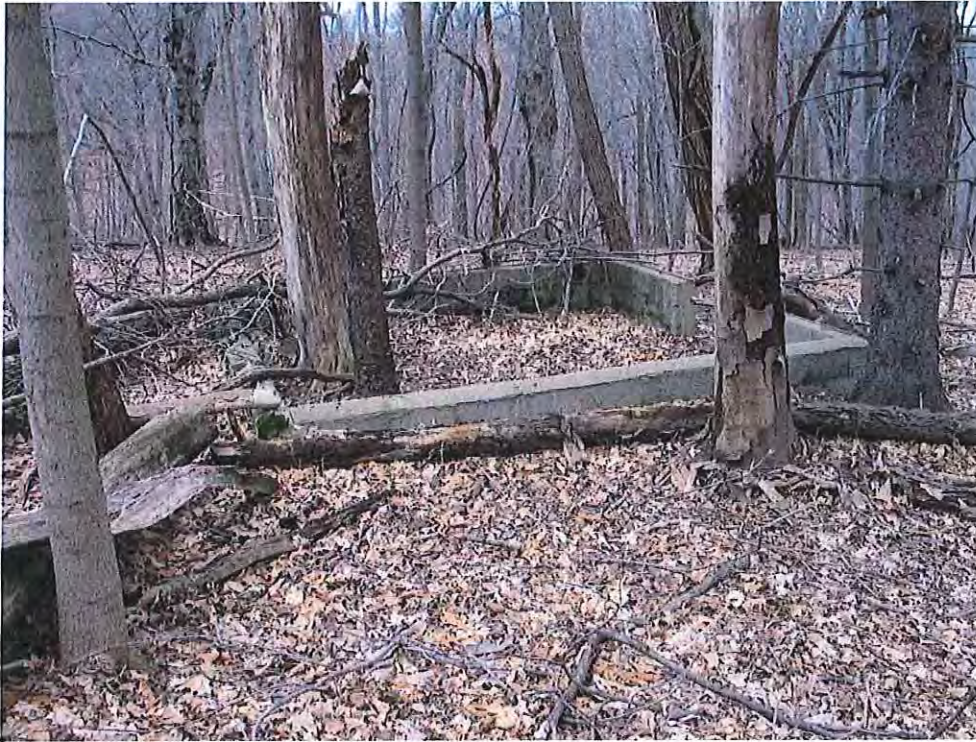
Photograph 47: Concrete foundation of former twentieth-century house at southeastern end of project site. View looking west.

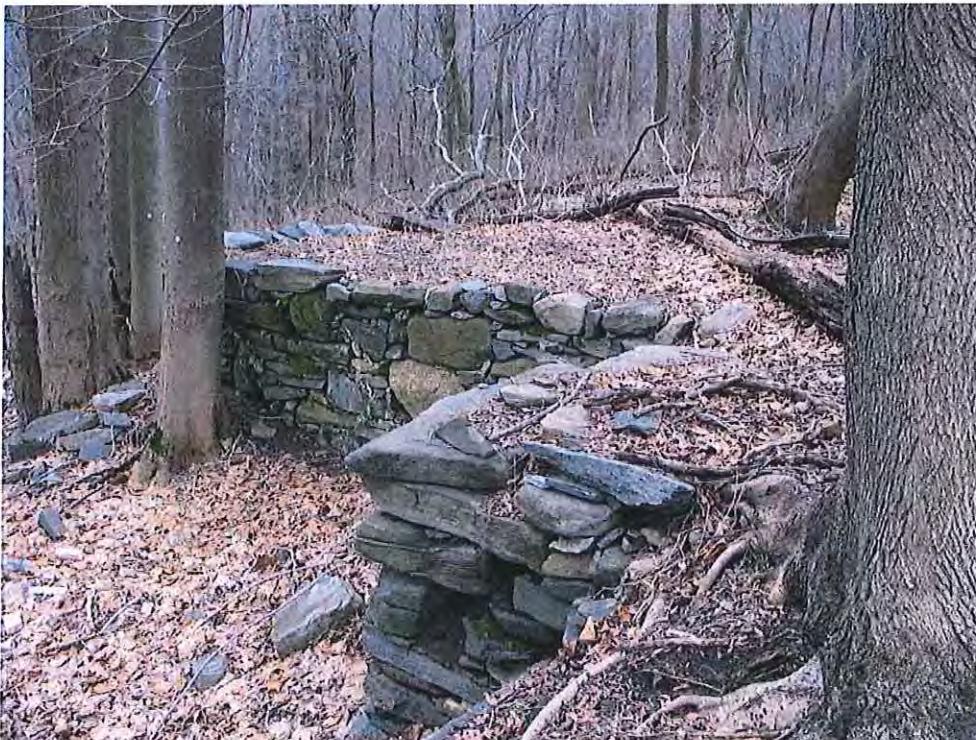
Photograph 48: Remains of the former Schneider residence, located on knoll near Sheldon Avenue. View looking south.

Near the Sheldon Avenue end of the parcel are remains of the former Schneider residence. The foundation, of fieldstone, is located along the side of a ridge. Remains of outbuildings were also visible. Artifacts littering the ground surface near these former buildings at the time of the field survey dated from the late nineteenth and early twentieth century.

The longevity of the Schneider occupation and the presence of the remainder of the dwelling foundation also warrant further investigation in the form of Phase II testing prior to any development of this location.

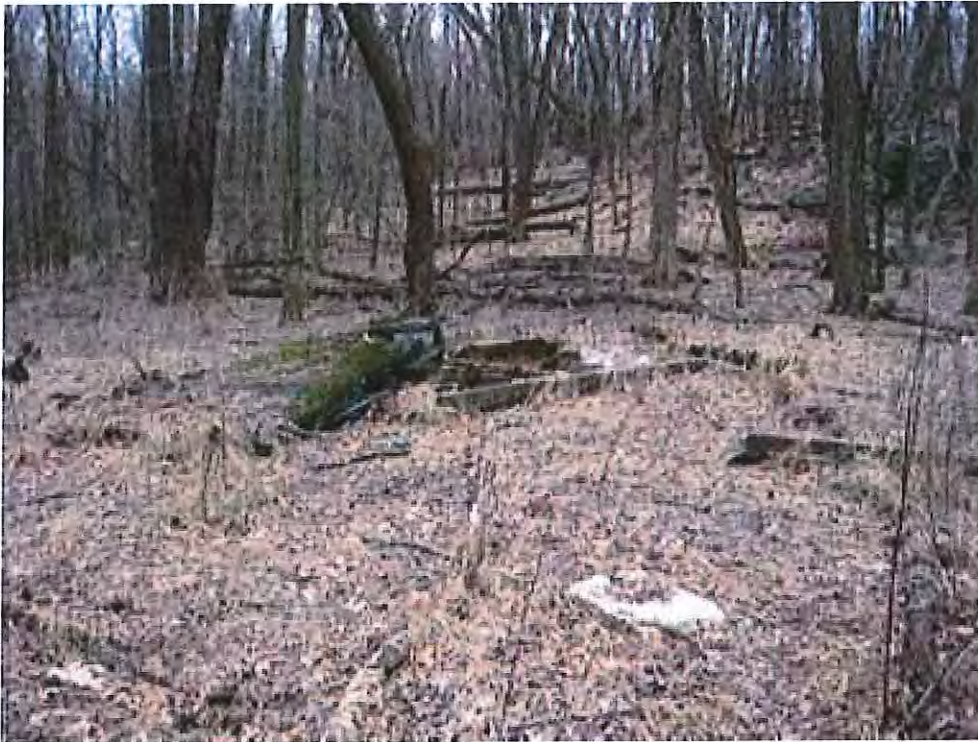
Photograph 49: Outbuilding of former Schneider residence, located south of the main house. View looking south.

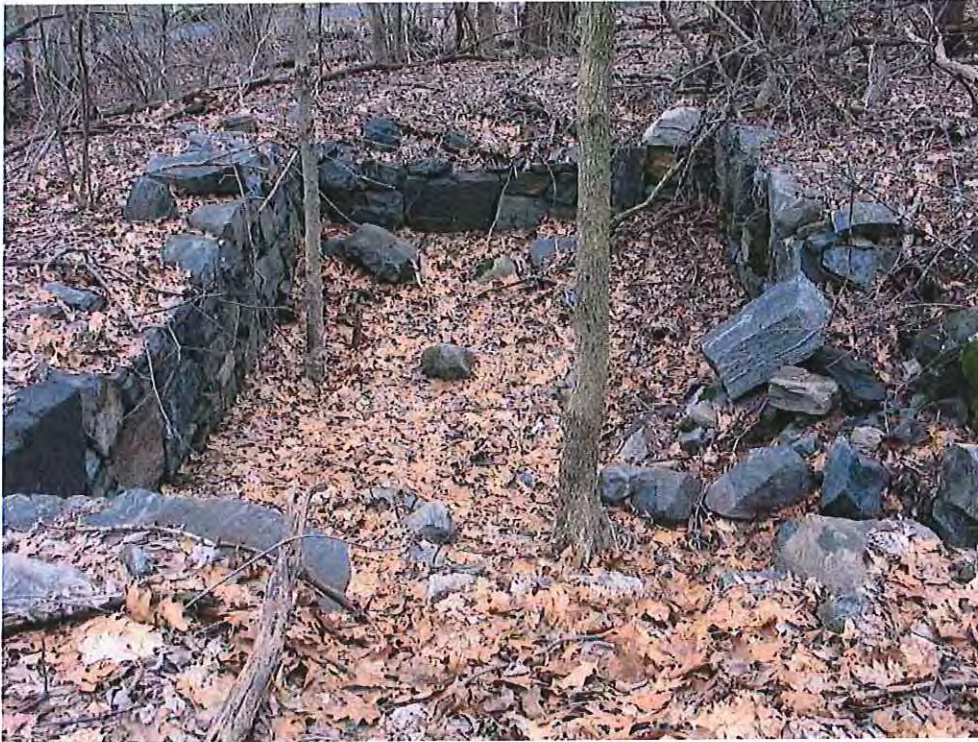
Photograph 51: Unmortared fieldstone foundation from a former house located south of Sheldon Avenue and just west of driveway marking eastern edge of project site. View looking west.

Near the northeastern edge of the project site, one unmortared fieldstone foundation from a former house is still visible. It is rectangular-shaped, and measures

During the initial site reconnaissance, a foundation of a small dwelling was observed. Additionally, remnants of a nearby stonewall were noted during field-testing. Documentary research confirmed that a historical farm/domestic compound once stood where the site was encountered. The presence of the intact foundation with associated artifacts indicates the need for Phase II field-testing prior to any development of this location.

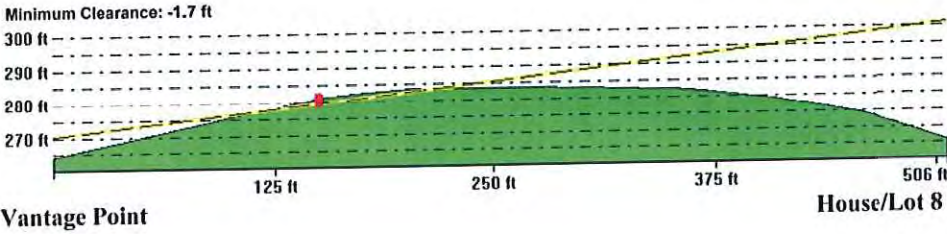
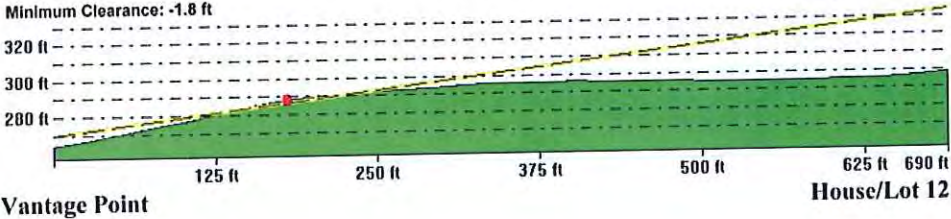
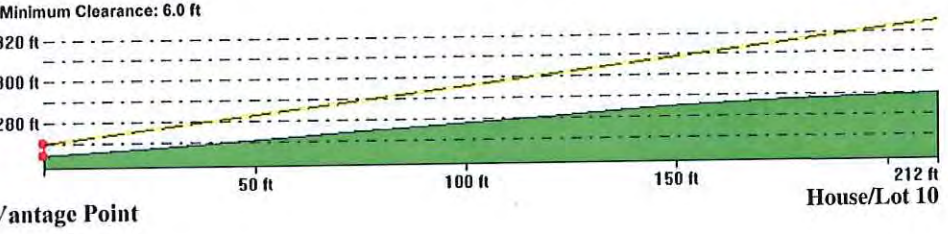
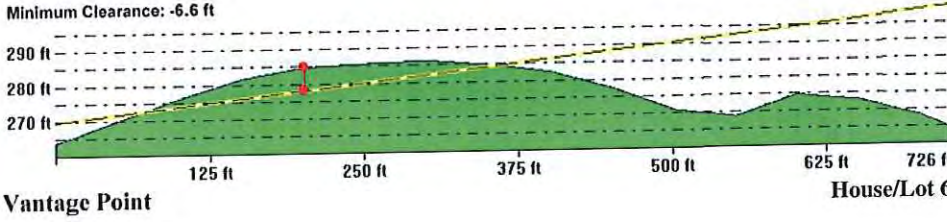
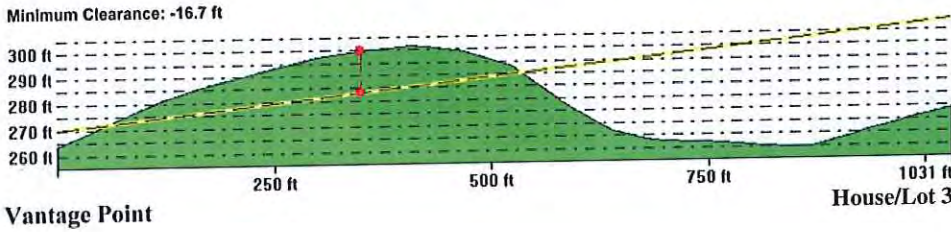
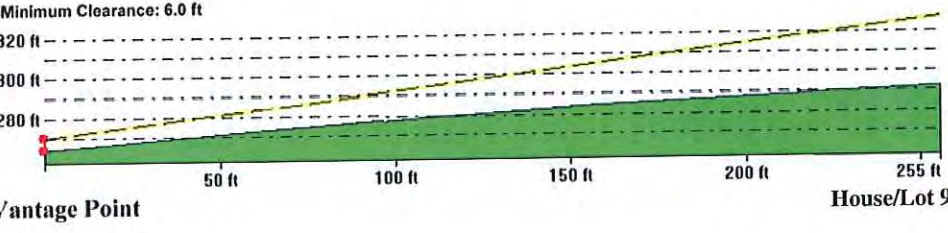
Exhibit 4-5
SIGHT LINES FROM
VANTAGE POINT 1
SOUTHERN END OF
WOODLAWN STREET
JARDIM ESTATES EAST
Tarrytown, New York

SIGHT LINES FROM VANTAGE POINT 1
SOUTHERN END OF WOODLAWN STREET TO NEW HOUSES

- **The southern end of Woodlawn Street** – The view from the southern end of Woodlawn Street is slightly sloping upwards, with the view of some homes in the foreground. The area is heavily wooded, and even in the leaves-off condition, the view is significantly obstructed in the distance by trees. In the near distance, there are existing homes that are visible.

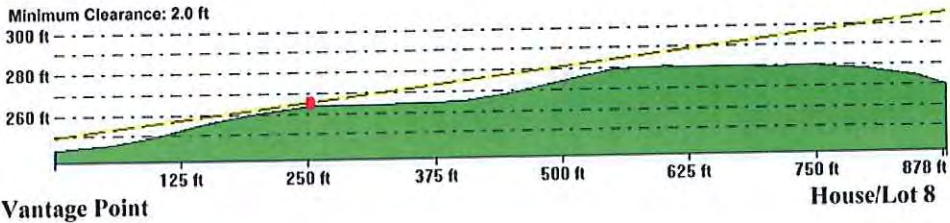
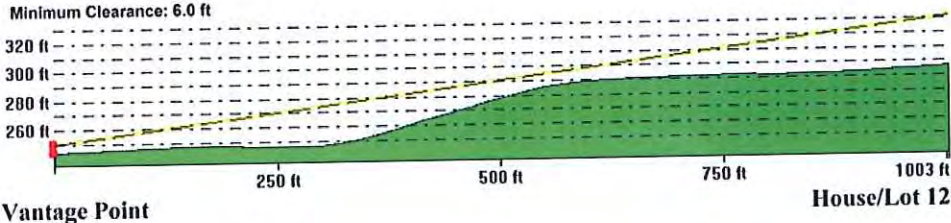
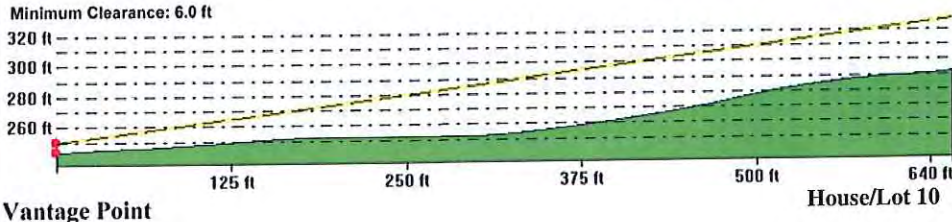
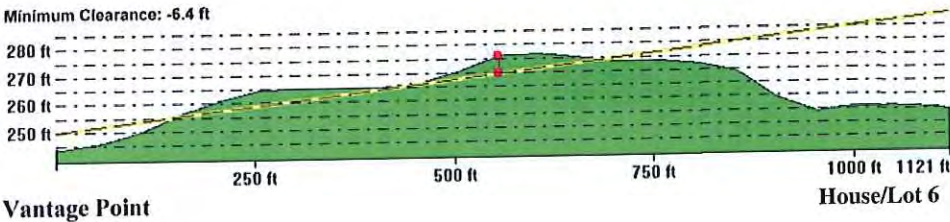
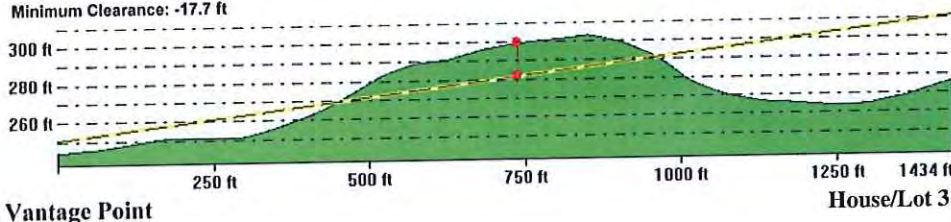
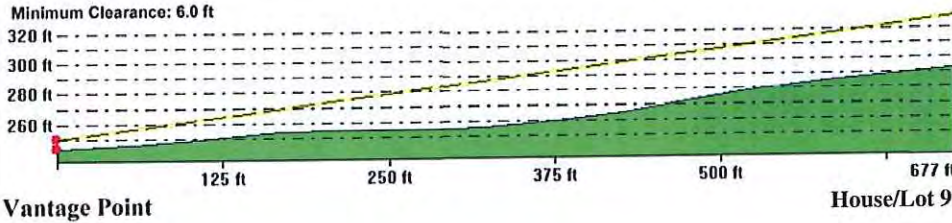
Exhibit 4-6
SIGHT LINES FROM
VANTAGE POINT 2
WALNUT STREET NEIGHBORHOOD
JARDIM ESTATES EAST
Tarrytown, New York

SIGHT LINES FROM VANTAGE POINT 2
WALNUT STREET NEIGHBORHOOD TO NEW HOUSES

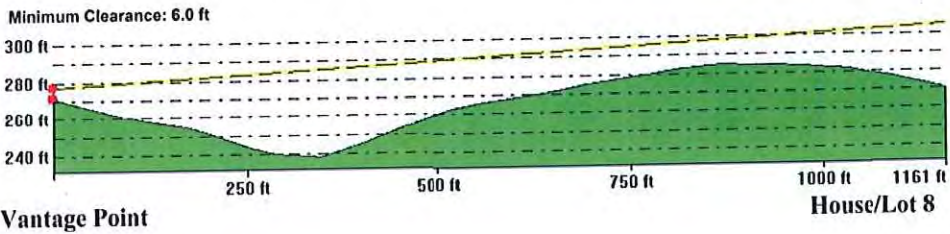
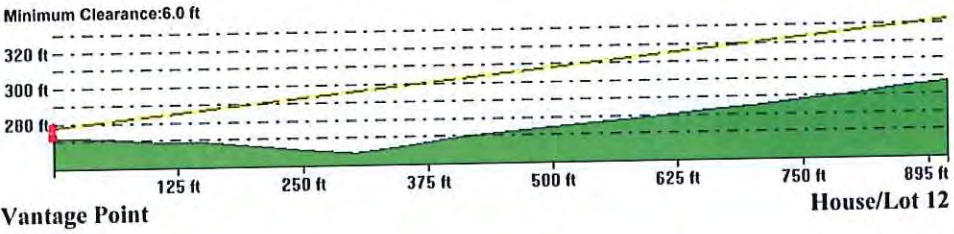
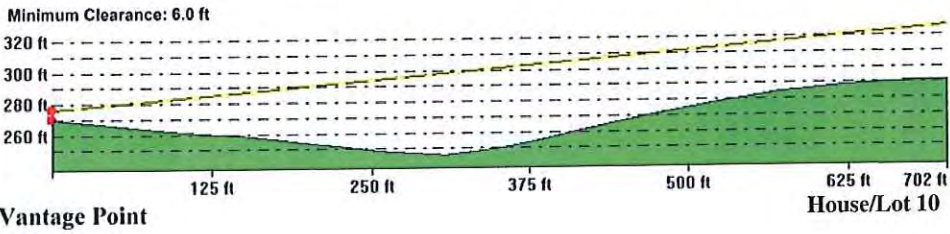
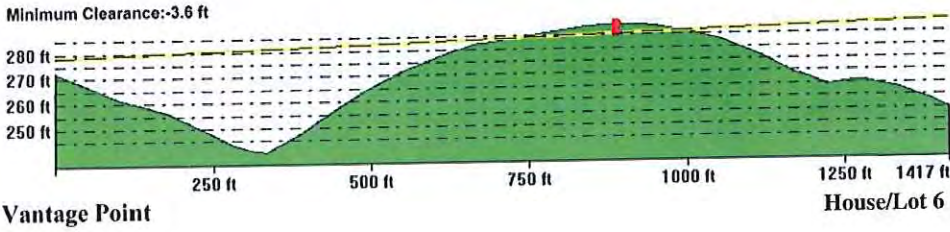
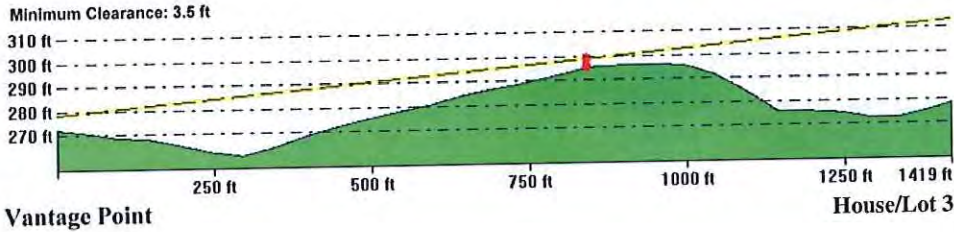
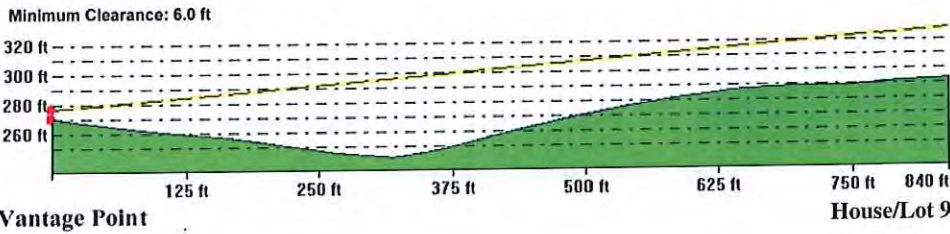
Exhibit 4-7
**SIGHT LINES FROM
VANTAGE POINT 3
NEIGHBORHOOD SOUTH OF
UPPER GRACEMERE LAKE**
JARDIM ESTATES EAST
Tarrytown, New York

**SIGHT LINES FROM VANTAGE POINT 3
NEIGHBORHOOD SOUTH OF UPPER GRACEMERE LAKE TO NEW HOUSES**

- **The neighborhood south of Upper Gracemere Lake** – The neighborhood south of Upper Gracemere Lake include a cluster of single family homes. These houses sit at roughly the same elevation as the homes in the Walnut Street neighborhood. These houses are surrounded to the east, west and south by dense wooded land, with obstructed views in leaf-off conditions. There are steep slopes to the southwest of this area.

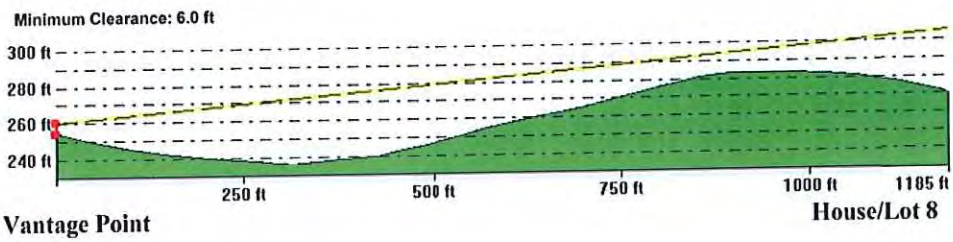
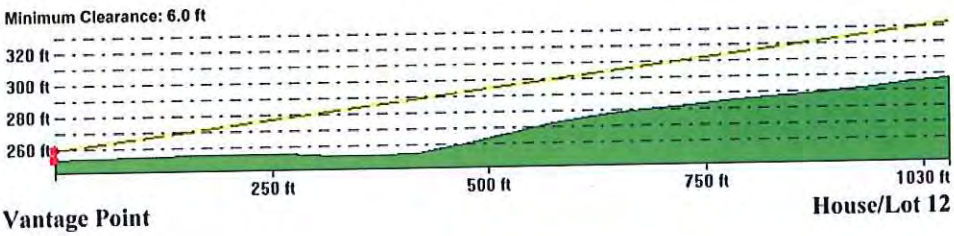
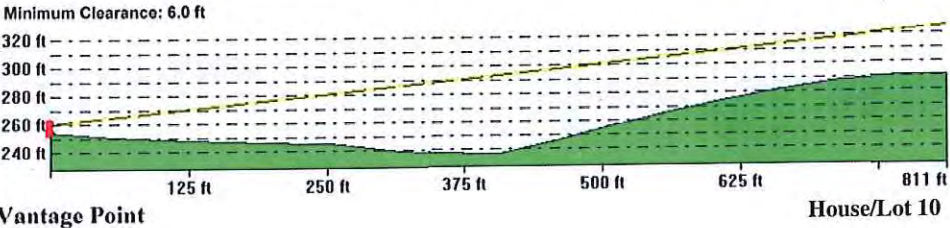
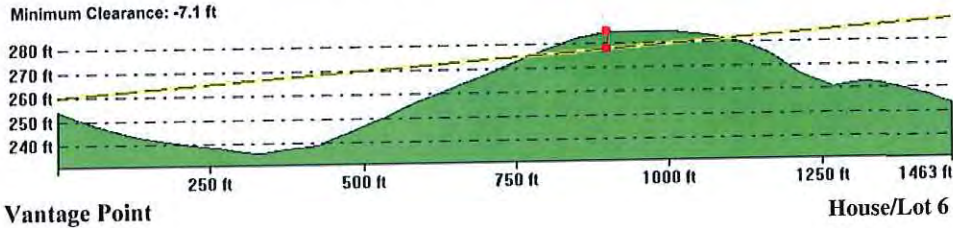
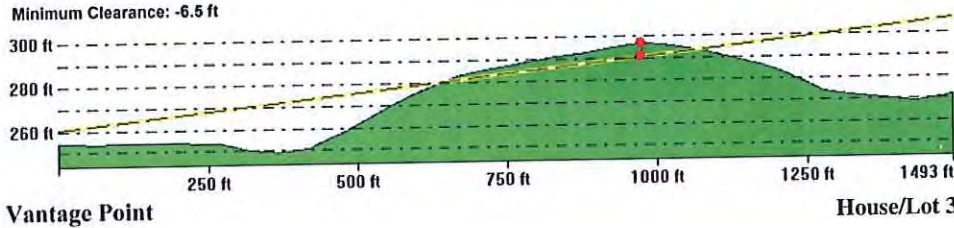
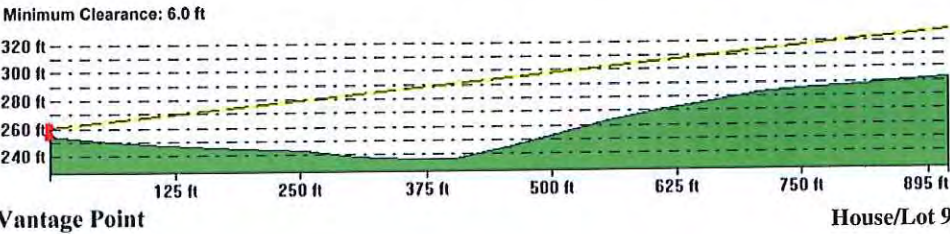
Exhibit 4-8
SIGHT LINES FROM
VANTAGE POINT 4
WESTERN PERIMETER OF
THER PROPERTY LOOKING EAST
JARDIM ESTATES EAST
Tarrytown, New York

SIGHT LINES FROM VANTAGE POINT 4
WESTERN PERIMETER OF THE PROPERTY LOOKING EAST TO NEW HOUSES

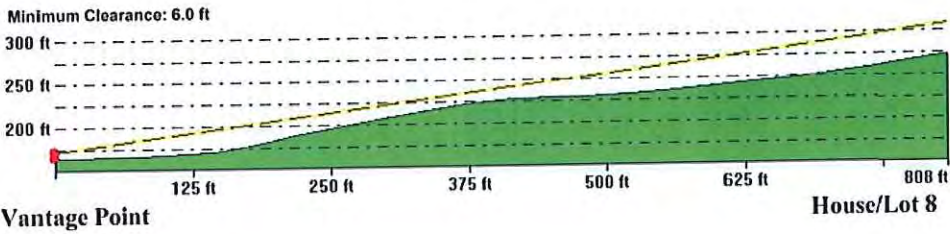
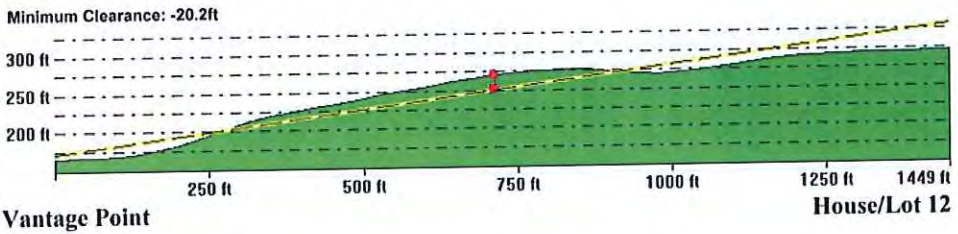
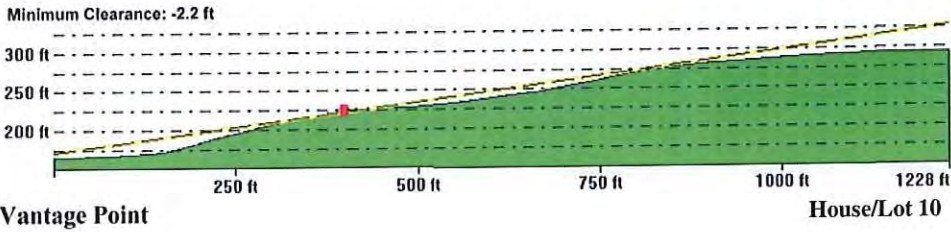
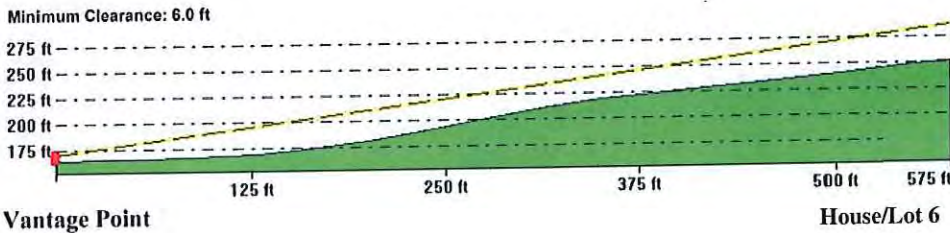
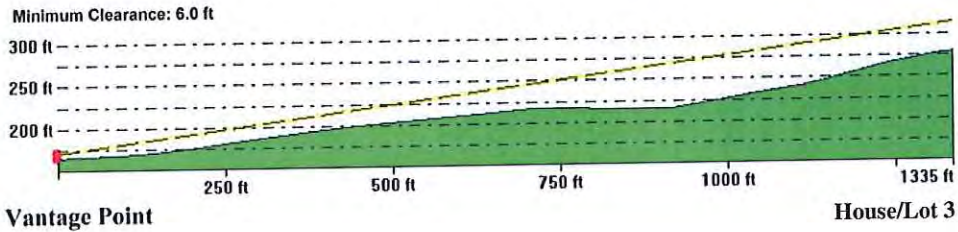
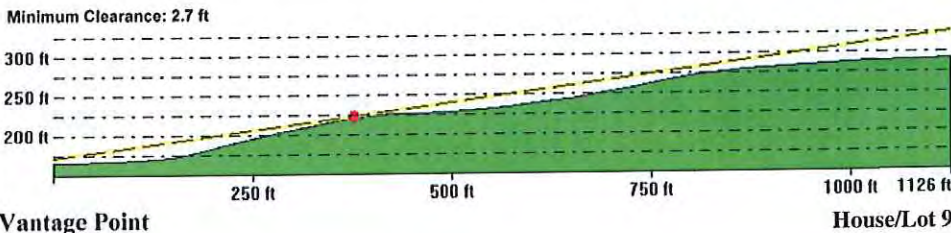
Exhibit 4-10
**SIGHT LINES FROM
VANTAGE POINT 6
SHELDON AVENUE
LOOKING SOUTH**
JARDIM ESTATES EAST
Tarrytown, New York

**SIGHT LINES FROM VANTAGE POINT 6
SHELDON AVENUE LOOKING SOUTH TO NEW HOUSES**

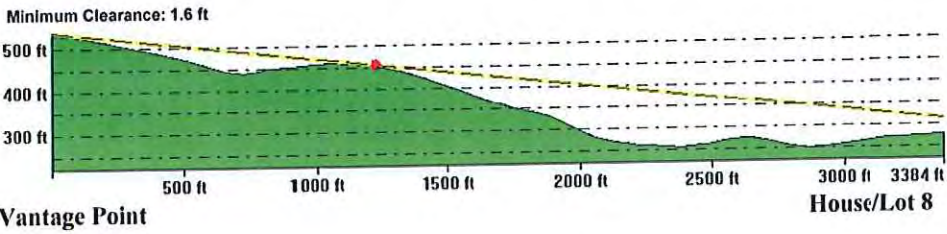
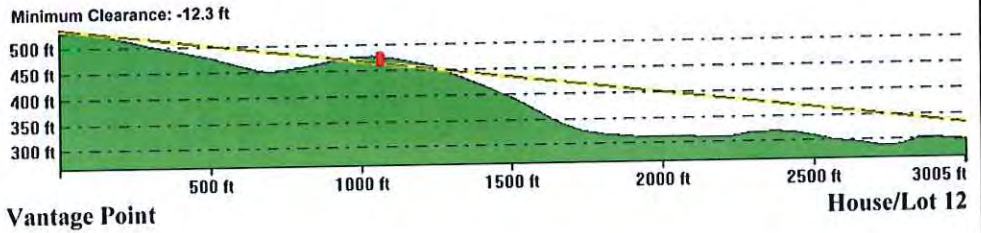
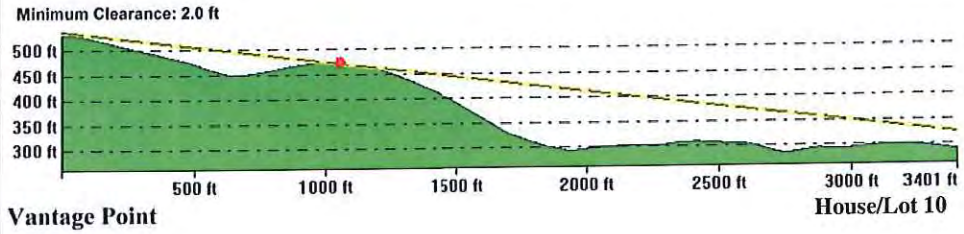
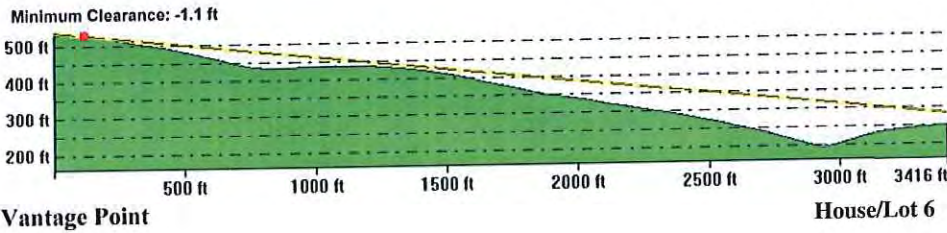
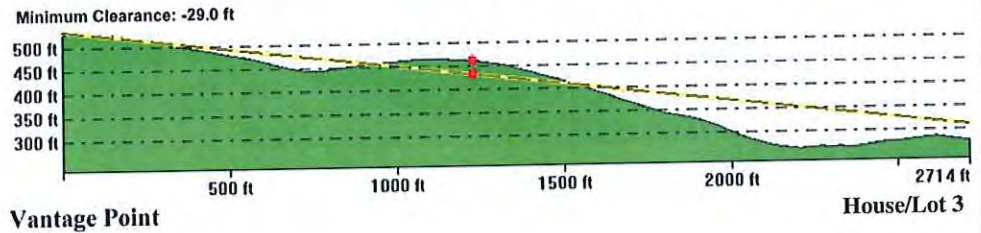
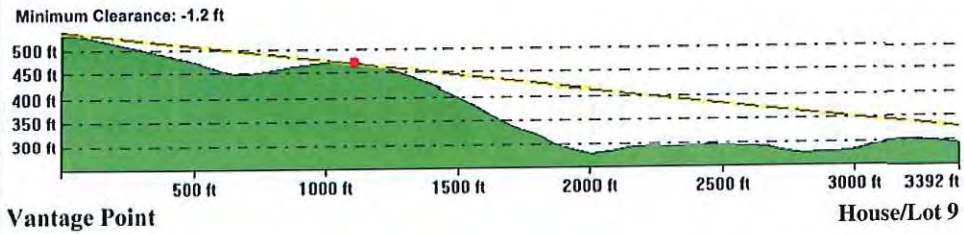
Exhibit 4-11
SIGHT LINES FROM
VANTAGE POINT 7A
PROMINENT LOCATIONS IN
TAXTER RIDGE PARK (LOC.1)
JARDIM ESTATES EAST
Tarrytown, New York

SIGHT LINES FROM VANTAGE POINT 7A
PROMINENT LOCATIONS IN TAXTER RIDGE PARK(LOCATION 1) TO NEW HOUSES

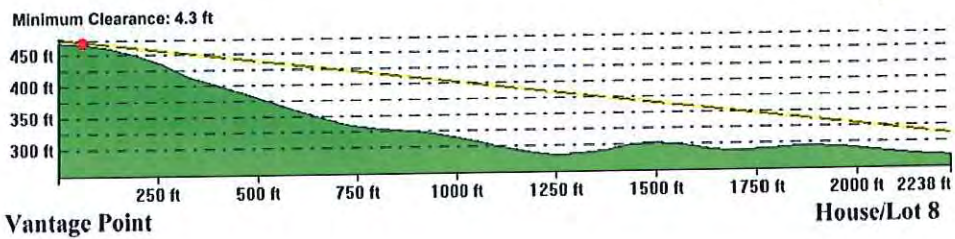
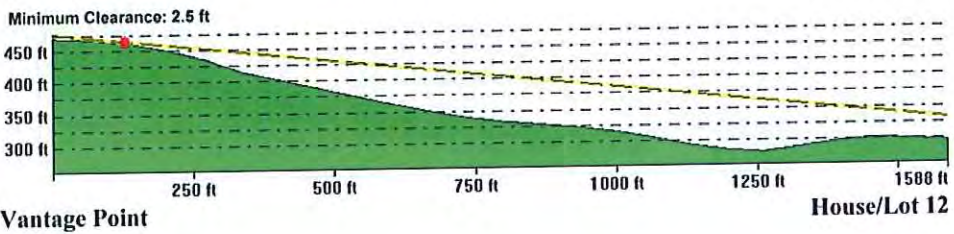
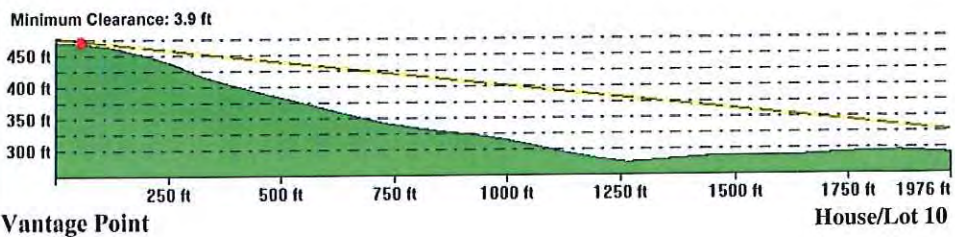
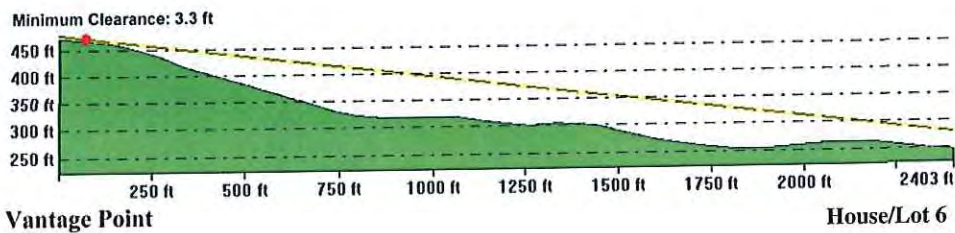
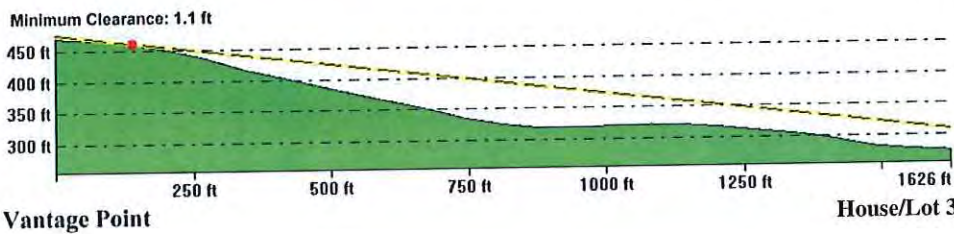
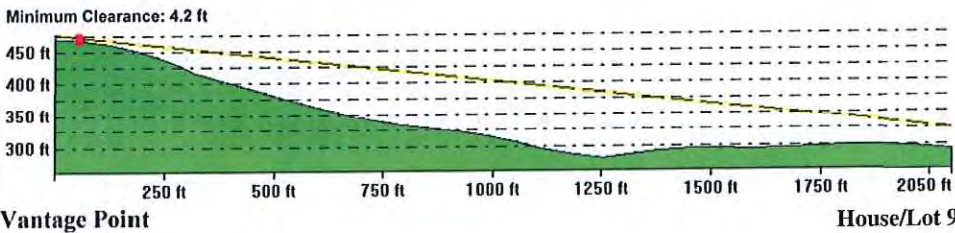
Exhibit 4-12
SIGHT LINES FROM
VANTAGE POINT 7B
PROMINENT LOCATIONS IN
TAXTER RIDGE PARK (LOC.2)
JARDIM ESTATES EAST
Tarrytown, New York

SIGHT LINES FROM VANTAGE POINT 7B
PROMINENT LOCATIONS IN TAXTER RIDGE PARK (LOCATION 2) TO NEW HOUSES)

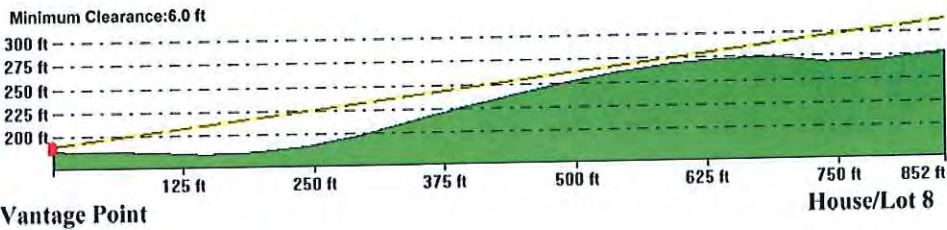
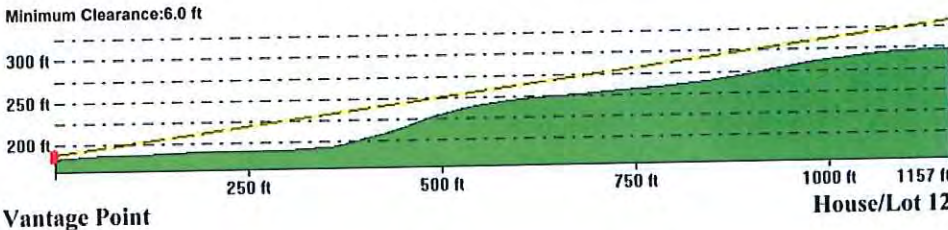
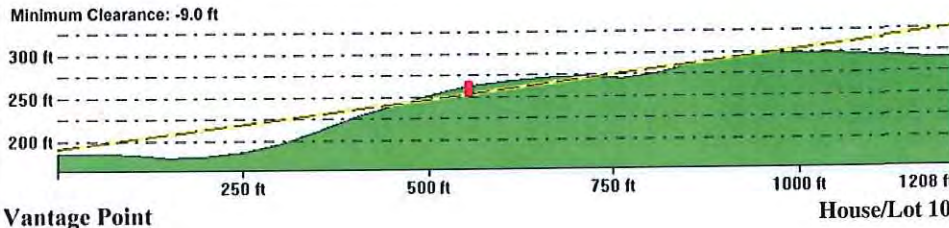
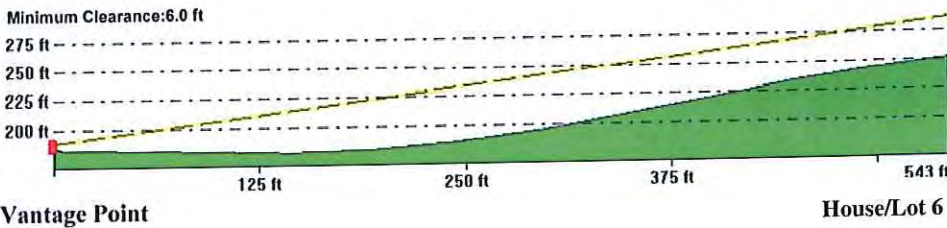
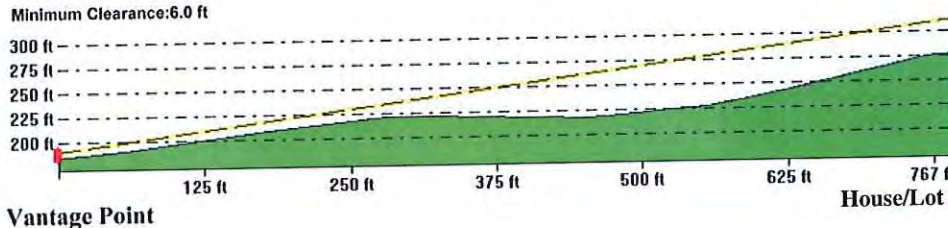
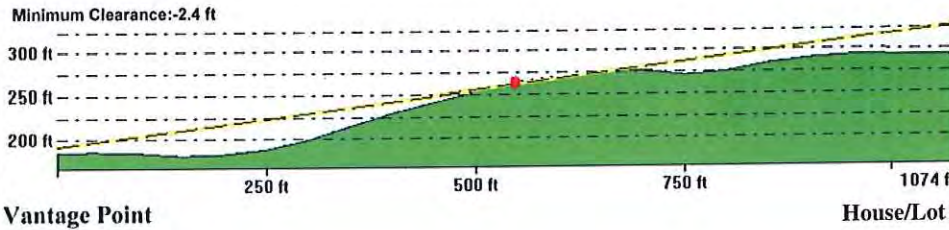
Exhibit 4-13
**SIGHT LINES FROM
VANTAGE POINT 8
BAGAROTTI PROPERTY**
JARDIM ESTATES EAST
Tarrytown, New York

SIGHT LINES FROM VANTAGE POINT 8
BAGAROTTI PROPERTY TO NEW HOUSES

- **The Bagarotti property** – The Bagarotti property is located adjacent to the project site to the east (see Exhibit 2-2, *Adjoining Property Owners*, map reference #4). The Bagarotti property contains a single family residence and garage, a 3.5 acre lake, forested land and landscaped areas. Vegetation and habitat within the Bagarotti property are similar to those found on the project site. The proposed lot 5 house is the nearest proposed structure located approximately 415 feet
